Access Compliance Report

Public Rights-of-Way

(Curb Ramps)

Intersection ID: 4199	Main Street: OLD_STATESVILLE_RD	Cross Street: W_W_T_HARRIS_BV	Location: NW
ADA ID: 0CE10F264E56	Ramp Type: Perp	Initial Pass/Fail: Fail	Overall Compliance: No
Severity Score: 33.75			
Codes/Mitigation Info/Possible Solution		Field Measurements/Component Compliance

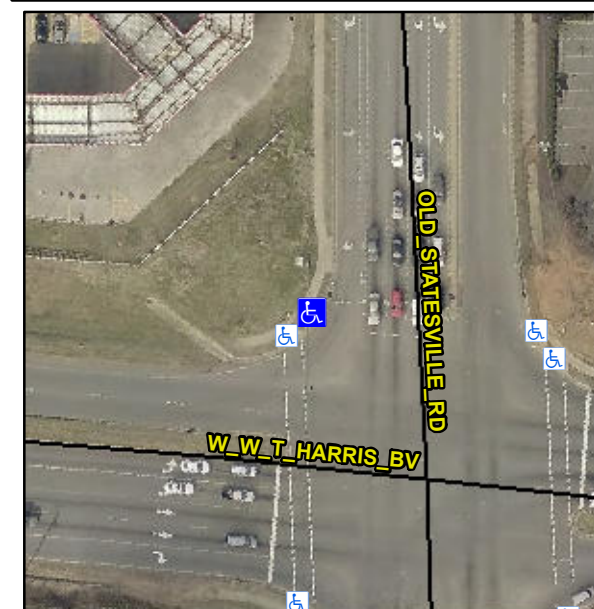
Not Found, R304.5.1, R304.2.2

Compliance	Description	Data	Compliance	Description	Data
N/A	Ramp Length (in)	59.0	No	Ramp Slope (%)	12.4
No	Ramp Width (in)	45.0	Yes	Ramp XSlope (%)	0.4
N/A	Flare Type LT	N/A	N/A	Flare Type RT	N/A
N/A	Flare Slope LT (%)	N/A	N/A	Flare Slope RT (%)	N/A
N/A	Flare Traversable LT?	N/A	N/A	Flare Traversable RT?	N/A
N/A	Landing Length (in)	N/A	N/A	DWS Provided?	N/A
N/A	Landing Width (in)	N/A	N/A	DWS Contrast?	N/A
N/A	Landing Slope (%)	N/A	N/A	DWS Length (in)	N/A
N/A	Landing X Slope (%)	N/A	N/A	DWS Full Width?	N/A
N/A	Landing Curb? (Y/N)	N/A	N/A	DWS Offset (in)	N/A
N/A	Shared Landing?	N/A			
N/A	Gutter Ponding?	N/A	N/A	Gutter Slope (%)	N/A
N/A	Gutter Lip Ht (in)	N/A	N/A	Gutter X Slope (%)	N/A
N/A	Painted X Walk1?	Yes	N/A	Painted X Walk2?	N/A
	X Walk 1 Direction	To SE		X Walk 2 Direction	N/A
N/A	X Walk 1 Width (in)	97.0	N/A	X Walk 2 Width (in)	N/A
	X Walk 1 Slope (%)	0.8		X Walk 2 Slope (%)	N/A
	X Walk 1 X Slope (%)	0.1		X Walk 2 X Slope (%)	N/A

N/A	Ramp inside XWalk1?	Yes	N/A	Ramp inside XWalk2?	N/A
	Road Slope (%)	N/A	N/A	Clear Space?	N/A
	Road X Slope (%)	N/A	N/A	Clear Space to XWalk (in)	N/A
N/A	Any Obstructions?	N/A	N/A	Storm Grate/Utility Hazard?	N/A
	Obstruction Type			Storm Grate/Utility Type	
		N/A			N/A
			Yes	Surface Condition? (G/P)	Good

Possible Solutions:

Remove & Replace Entire Ramp.
