Access Compliance Report

Public Rights-of-Way

(Curb Ramps)

Intersection ID: 14977	Main Street: BUCHANAN_ST	Cross Street: KENILWORTH_AV	Location: E
ADA ID: 0CF3AEA8B6B1	Ramp Type: Perp	Initial Pass/Fail: Fail	Overall Compliance: No
		Severity Score: 1.25

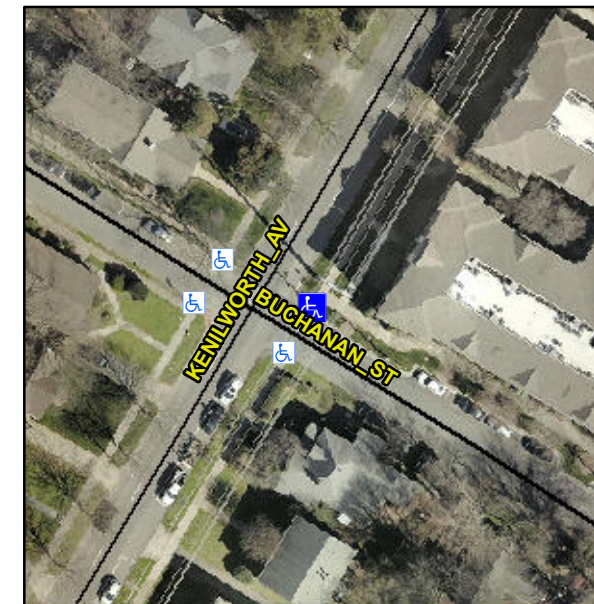
N/A

Compliance	Description	Data	Compliance	Description	Data
N/A	Ramp Length (in)	59.0	Yes	Ramp Slope (%)	5.2
Yes	Ramp Width (in)	48.0	No	Ramp XSlope (%)	2.1
N/A	Flare Type LT	N/A	N/A	Flare Type RT	N/A
N/A	Flare Slope LT (%)	N/A	N/A	Flare Slope RT (%)	N/A
N/A	Flare Traversable LT?	N/A	N/A	Flare Traversable RT?	N/A
N/A	Landing Length (in)	N/A	N/A	DWS Provided?	N/A
N/A	Landing Width (in)	N/A	N/A	DWS Contrast?	N/A
N/A	Landing Slope (%)	N/A	N/A	DWS Length (in)	N/A
N/A	Landing X Slope (%)	N/A	N/A	DWS Full Width?	N/A
N/A	Landing Curb? (Y/N)	N/A	N/A	DWS Offset (in)	N/A
N/A	Shared Landing?	N/A			
N/A	Gutter Ponding?	N/A	N/A	Gutter Slope (%)	N/A
N/A	Gutter Lip Ht (in)	N/A	N/A	Gutter X Slope (%)	N/A
N/A	Painted X Walk1?	No	N/A	Painted X Walk2?	N/A
	X Walk 1 Direction	To SE		X Walk 2 Direction	N/A
N/A	X Walk 1 Width (in)	N/A	N/A	X Walk 2 Width (in)	N/A
	X Walk 1 Slope (%)	1.3		X Walk 2 Slope (%)	N/A
	X Walk 1 X Slope (%)	2.9		X Walk 2 X Slope (%)	N/A

N/A	Ramp inside XWalk1?	N/A	N/A	Ramp inside XWalk2?	N/A
	Road Slope (%)	N/A	N/A	Clear Space?	N/A
	Road X Slope (%)	N/A	N/A	Clear Space to XWalk (in)	N/A
N/A	Any Obstructions?	N/A	N/A	Storm Grate/Utility Hazard?	N/A
	Obstruction Type			Storm Grate/Utility Type	
		N/A			N/A
			Yes	Surface Condition? (G/P)	Good

Possible Solutions:

Remove & Replace Entire Ramp.

R304.5.3

\$ 1850.00
