Access Compliance Report

Public Rights-of-Way

(Curb Ramps)

Intersection ID: N/A	Main Street: TYVOLA_RD	Cross Street: SPEER_BV	Location: NW
ADA ID: 0CF52946E882	Ramp Type: Perp	Initial Pass/Fail: Fail	Overall Compliance: No
		Severity Score: 12.5

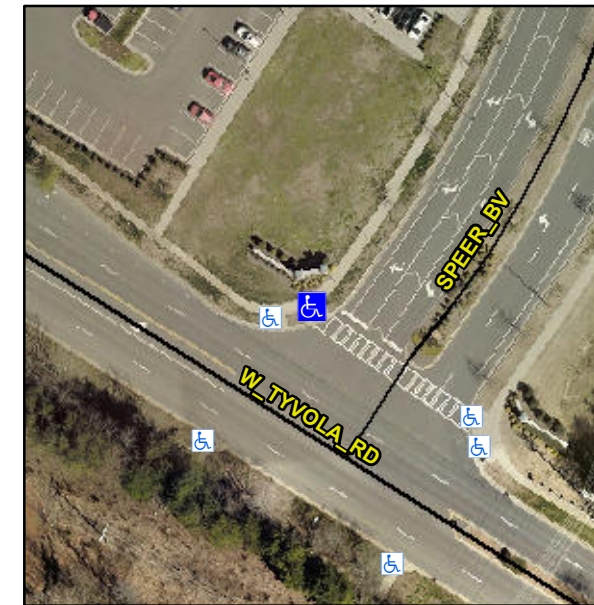
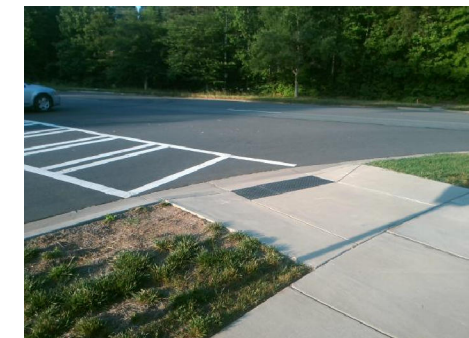
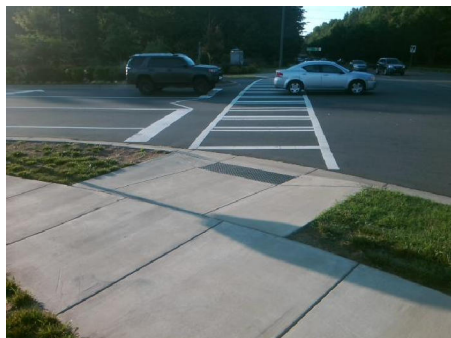
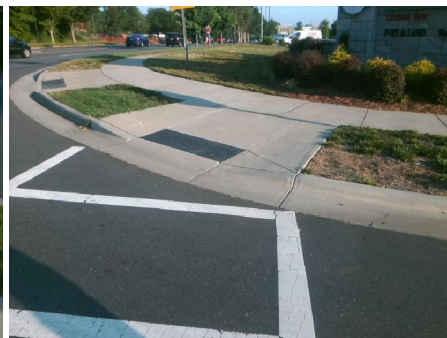
Not Found, R304.5.3

Compliance	Description	Data	Compliance	Description	Data
N/A	Ramp Length (in)	95.0	Yes	Ramp Slope (%)	6.8
Yes	Ramp Width (in)	58.0	No	Ramp XSlope (%)	5.6
N/A	Flare Type LT	N/A	N/A	Flare Type RT	N/A
N/A	Flare Slope LT (%)	N/A	N/A	Flare Slope RT (%)	N/A
N/A	Flare Traversable LT?	N/A	N/A	Flare Traversable RT?	N/A
N/A	Landing Length (in)	N/A	N/A	DWS Provided?	N/A
N/A	Landing Width (in)	N/A	N/A	DWS Contrast?	N/A
N/A	Landing Slope (%)	N/A	N/A	DWS Length (in)	N/A
N/A	Landing X Slope (%)	N/A	N/A	DWS Full Width?	N/A
N/A	Landing Curb? (Y/N)	N/A	N/A	DWS Offset (in)	N/A
N/A	Shared Landing?	N/A			
N/A	Gutter Ponding?	N/A	N/A	Gutter Slope (%)	N/A
N/A	Gutter Lip Ht (in)	N/A	N/A	Gutter X Slope (%)	N/A
N/A	Painted X Walk1?	Yes	N/A	Painted X Walk2?	N/A
	X Walk 1 Direction	To SE		X Walk 2 Direction	N/A
N/A	X Walk 1 Width (in)	113.0	N/A	X Walk 2 Width (in)	N/A
	X Walk 1 Slope (%)	5.0		X Walk 2 Slope (%)	N/A
	X Walk 1 X Slope (%)	5.3		X Walk 2 X Slope (%)	N/A

N/A	Ramp inside XWalk1?	Yes	N/A	Ramp inside XWalk2?	N/A
	Road Slope (%)	N/A	N/A	Clear Space?	N/A
	Road X Slope (%)	N/A	N/A	Clear Space to XWalk (in)	N/A
N/A	Any Obstructions?	N/A	N/A	Storm Grate/Utility Hazard?	N/A
	Obstruction Type			Storm Grate/Utility Type	
		N/A			N/A
			Yes	Surface Condition? (G/P)	Good

Remove & Replace Entire Ramp.

Total Cost: \$ 1850.00
