# Access Compliance Report

## Public Rights-of-Way

### (Curb Ramps)

Intersection ID: 7806	Main Street: MANLEY_ST	Cross Street: ROZZELLES_FERRY_RD	Location: N
ADA ID: 0CFBCEA2DC6D	Ramp Type: Perp	Initial Pass/Fail: Fail	Overall Compliance: No
Severity Score: 26.25			
Codes/Mitigation Info/Possible Solution		Field Measurements/Component Compliance

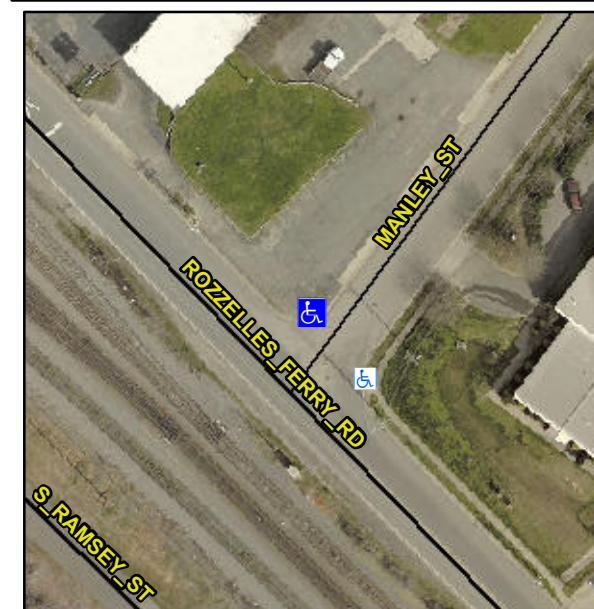
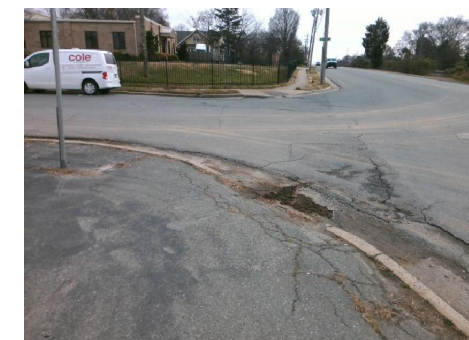
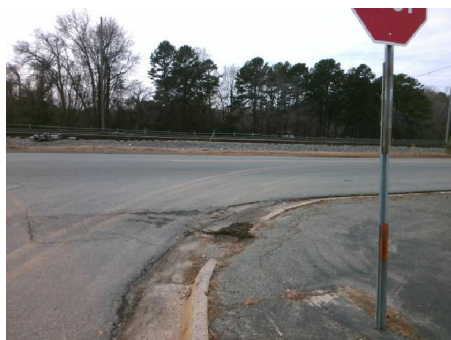
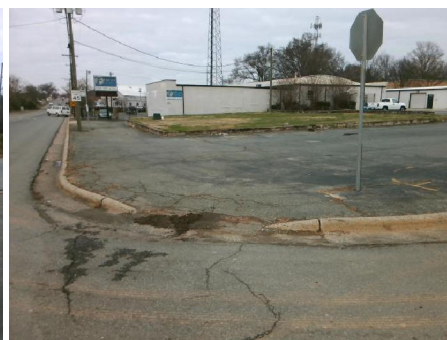
Compliance	Description	Data	Compliance	Description	Data
N/A	Ramp Length (in)	33.0	No	Ramp Slope (%)	24.5
Yes	Ramp Width (in)	82.0	No	Ramp XSlope (%)	2.8
N/A	Flare Type LT	N/A	N/A	Flare Type RT	N/A
N/A	Flare Slope LT (%)	N/A	N/A	Flare Slope RT (%)	N/A
N/A	Flare Traversable LT?	N/A	N/A	Flare Traversable RT?	N/A
N/A	Landing Length (in)	N/A	N/A	DWS Provided?	N/A
N/A	Landing Width (in)	N/A	N/A	DWS Contrast?	N/A
N/A	Landing Slope (%)	N/A	N/A	DWS Length (in)	N/A
N/A	Landing X Slope (%)	N/A	N/A	DWS Full Width?	N/A
N/A	Landing Curb? (Y/N)	N/A	N/A	DWS Offset (in)	N/A
N/A	Shared Landing?	N/A			
N/A	Gutter Ponding?	N/A	N/A	Gutter Slope (%)	N/A
N/A	Gutter Lip Ht (in)	N/A	N/A	Gutter X Slope (%)	N/A
N/A	Painted X Walk1?	No	N/A	Painted X Walk2?	N/A
	X Walk 1 Direction	To SE		X Walk 2 Direction	N/A
N/A	X Walk 1 Width (in)	N/A	N/A	X Walk 2 Width (in)	N/A
	X Walk 1 Slope (%)	4.7		X Walk 2 Slope (%)	N/A
	X Walk 1 X Slope (%)	0.1		X Walk 2 X Slope (%)	N/A

N/A	Ramp inside XWalk1?	N/A	N/A	Ramp inside XWalk2?	N/A
	Road Slope (%)	N/A	N/A	Clear Space?	N/A
	Road X Slope (%)	N/A	N/A	Clear Space to XWalk (in)	N/A
N/A	Any Obstructions?	N/A	N/A	Storm Grate/Utility Hazard?	N/A
	Obstruction Type			Storm Grate/Utility Type	
		N/A			N/A
		Yes		Surface Condition? (G/P)	Good

**Remove & Replace Entire Ramp.**

**R304.2.2, R304.5.3**

**\$ 1850.00**
