# Access Compliance Report

## Public Rights-of-Way

### (Curb Ramps)

| Intersection ID: 16154 | Main Street: LILAC_RD | Cross Street: PARK_RD | Location: SE |

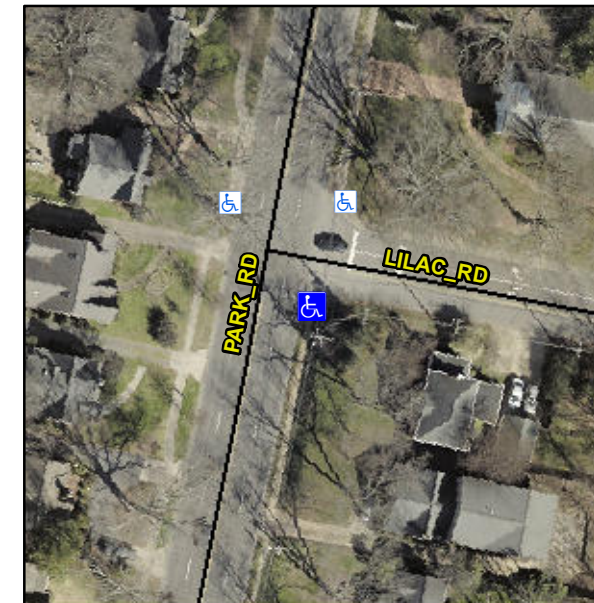
| ADA ID: 0D0EACFE7639 | Ramp Type: PerpDiag | Initial Pass/Fail: Fail | Overall Compliance: No |

| Compliance | Description | Data | Compliance | Description | Data |
|---|---|---|---|---|---|
| N/A | Ramp Length (in) | 61.0 | No | Ramp Slope (%) | 10.8 |
| No | Ramp Width (in) | 30.0 | No | Ramp XSlope (%) | 5.7 |

**Remove & Replace Curb Ramp With Two New Directional Ramps or Equivalent.**

**R304.5.1, R304.2.2, R304.5.3**
