Access Compliance Report

Public Rights-of-Way

(Curb Ramps)

Intersection ID: 43750	Main Street: POTTERS_GLEN_RD	Cross Street: EARTHENWARE_DR	Location:	W
ADA ID: 0D15CA4515F6	Ramp Type: PerpDiag	Initial Pass/Fail: Fail	Overall Compliance: No	Severity Score: 25
Codes/Mitigation Info/Possible Solution		Field Measurements/Component Compliance

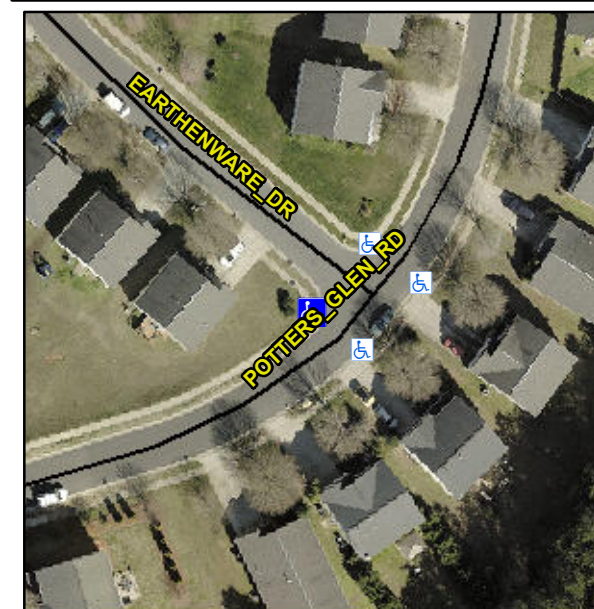
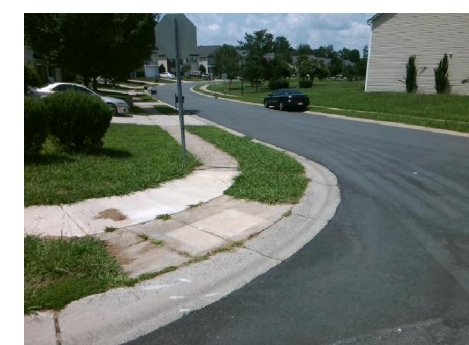
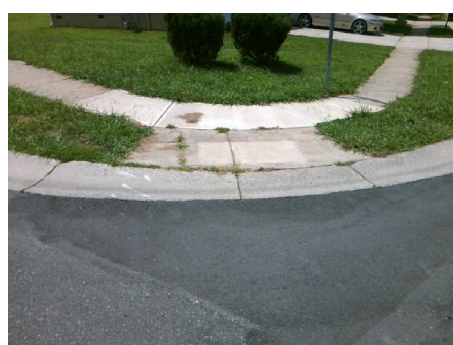
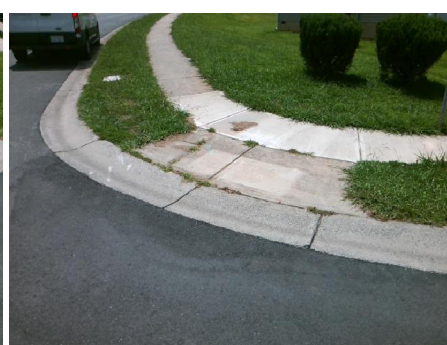
Compliance	Description	Data	Compliance	Description	Data
N/A	Ramp Length (in)	46.0	No	Ramp Slope (%)	10.6
Yes	Ramp Width (in)	50.0	No	Ramp XSlope (%)	5.3
N/A	Flare Type LT	N/A	N/A	Flare Type RT	N/A
N/A	Flare Slope LT (%)	N/A	N/A	Flare Slope RT (%)	N/A
N/A	Flare Traversable LT?	N/A	N/A	Flare Traversable RT?	N/A
N/A	Landing Length (in)	N/A	N/A	DWS Provided?	N/A
N/A	Landing Width (in)	N/A	N/A	DWS Contrast?	N/A
N/A	Landing Slope (%)	N/A	N/A	DWS Length (in)	N/A
N/A	Landing X Slope (%)	N/A	N/A	DWS Full Width?	N/A
N/A	Landing Curb? (Y/N)	N/A	N/A	DWS Offset (in)	N/A
N/A	Shared Landing?	N/A			
N/A	Gutter Ponding?	N/A	N/A	Gutter Slope (%)	N/A
N/A	Gutter Lip Ht (in)	N/A	N/A	Gutter X Slope (%)	N/A
N/A	Painted X Walk1?	No	N/A	Painted X Walk2?	No
	X Walk 1 Direction	To SE		X Walk 2 Direction	To NE
N/A	X Walk 1 Width (in)	N/A	N/A	X Walk 2 Width (in)	N/A
	X Walk 1 Slope (%)	4.2		X Walk 2 Slope (%)	0.3
	X Walk 1 X Slope (%)	2.8		X Walk 2 X Slope (%)	5.3

N/A	Ramp inside XWalk1?	N/A	N/A	Ramp inside XWalk2?	N/A
	Road Slope (%)	4.5	N/A	Clear Space?	N/A
	Road X Slope (%)	2.9	N/A	Clear Space to XWalk (in)	N/A
N/A	Any Obstructions?	N/A	N/A	Storm Grate/Utility Hazard?	N/A
	Obstruction Type			Storm Grate/Utility Type	
		N/A			N/A
			Yes	Surface Condition? (G/P)	Good

Possible Solutions:

Remove & Replace Curb Ramp With Two New Directional Ramps or Equivalent.

R304.2.2, R304.5.3
