# Access Compliance Report

## Public Rights-of-Way

### (Curb Ramps)

Intersection ID: 14403	Main Street: ALBEMARLE_RD	Cross Street: ORCHARD_RIDGE_DR	Location: SE
ADA ID: 0D18CEB71572	Ramp Type: Perp	Initial Pass/Fail: Fail	Overall Compliance: No
		Severity Score: 12.5

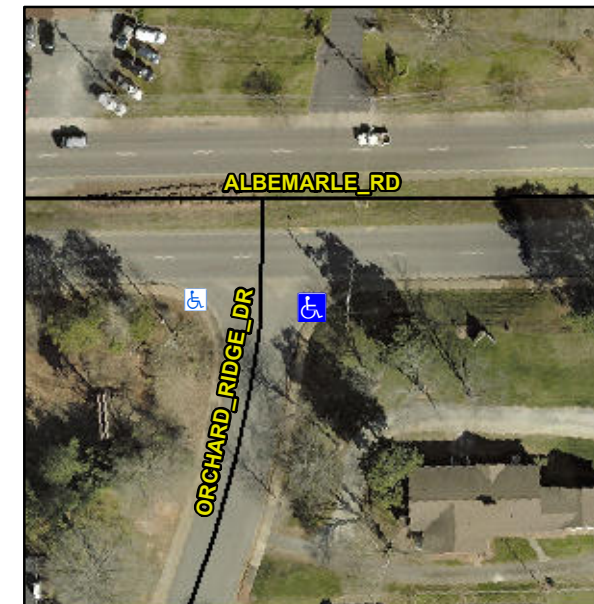
**Not Found, R304.2.2**

Compliance	Description	Data	Compliance	Description	Data
N/A	Ramp Length (in)	60.0	No	Ramp Slope (%)	8.5
Yes	Ramp Width (in)	48.0	Yes	Ramp XSlope (%)	0.8
N/A	Flare Type LT	N/A	N/A	Flare Type RT	N/A
N/A	Flare Slope LT (%)	N/A	N/A	Flare Slope RT (%)	N/A
N/A	Flare Traversable LT?	N/A	N/A	Flare Traversable RT?	N/A
N/A	Landing Length (in)	N/A	N/A	DWS Provided?	N/A
N/A	Landing Width (in)	N/A	N/A	DWS Contrast?	N/A
N/A	Landing Slope (%)	N/A	N/A	DWS Length (in)	N/A
N/A	Landing X Slope (%)	N/A	N/A	DWS Full Width?	N/A
N/A	Landing Curb? (Y/N)	N/A	N/A	DWS Offset (in)	N/A
N/A	Shared Landing?	N/A			
N/A	Gutter Ponding?	N/A	N/A	Gutter Slope (%)	N/A
N/A	Gutter Lip Ht (in)	N/A	N/A	Gutter X Slope (%)	N/A
N/A	Painted X Walk1?	No	N/A	Painted X Walk2?	N/A
	X Walk 1 Direction	To W		X Walk 2 Direction	N/A
N/A	X Walk 1 Width (in)	N/A	N/A	X Walk 2 Width (in)	N/A
	X Walk 1 Slope (%)	2.0		X Walk 2 Slope (%)	N/A
	X Walk 1 X Slope (%)	0.3		X Walk 2 X Slope (%)	N/A

**Remove & Replace Entire Ramp.**

Total Cost: \$ 1850.00
