Access Compliance Report Public Rights-of-Way (Curb Ramps)

Intersection ID: 13818Main Street: CENTRAL_AVCross Street: SHERIDAN_DRLocation:NWADA ID: 0D1F7BDB3982Ramp Type: PerpInitial Pass/Fail: FailOverall Compliance: NoSeverity Score: 36.25

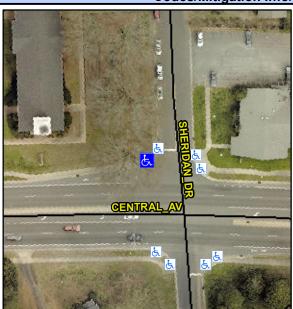
Field Measurements/Component Compliance						
Compliance Description Date		Data	Comp	liance Description	Data	
N/A	Ramp Length (in)	60.0	Yes	Ramp Slope (%)	6.5	
No	Ramp Width (in)	31.0	No	Ramp XSlope (%)	2.3	
N/A	Flare Type LT	N/A	N/A	Flare Type RT	N/A	
N/A	Flare Slope LT (%)	N/A	N/A	Flare Slope RT (%)	N/A	
N/A	Flare Traversable LT?	N/A	N/A	Flare Traversable RT?	N/A	
N/A	Landing Length (in)	N/A	N/A	DWS Provided?	N/A	
N/A	Landing Width (in)	N/A	N/A	DWS Contrast?	N/A	
N/A	Landing Slope (%)	N/A	N/A	DWS Length (in)	N/A	
N/A	Landing X Slope (%)	N/A	N/A	DWS Full Width?	N/A	
N/A	Landing Curb? (Y/N)	N/A	N/A	DWS Offset (in)	N/A	
N/A	Shared Landing?	N/A				
N/A	Gutter Ponding?	N/A	N/A	Gutter Slope (%)	N/A	
N/A	Gutter Lip Ht (in)	N/A	N/A	Gutter X Slope (%)	N/A	
N/A	Painted X Walk1?	No	N/A	Painted X Walk2?	N/A	
	X Walk 1 Direction	To S		X Walk 2 Direction	N/A	
N/A	X Walk 1 Width (in)	N/A	N/A	X Walk 2 Width (in)	N/A	
	X Walk 1 Slope (%)	0.6		X Walk 2 Slope (%)	N/A

X Walk 1 X Slope (%)	1.4		X Walk 2 X Slope (%)	N/A	
N/A	Ramp inside XWalk1?	N/A	N/A	Ramp inside XWalk2?	N/A	
	Road Slope (%)	N/A	N/A	Clear Space?	N/A	
	Road X Slope (%)	N/A	N/A	Clear Space to XWalk (in)	N/A	
N/A	Any Obstructions?	N/A	N/A	Storm Grate/Utility Hazard?	N/A	
	Obstruction Type			Storm Grate/Utility Type		
		N/A			N/A	
			Yes	Surface Condition? (G/P)	Good

Possible Solutions:	9		
Remove & Replace Entire Ramp.			
	ı		
	ı		
	I		
	I		
	I		
Surveyor Notes:	ı		
N/A	I		
	ı		
PROW/ADA:			
Not Found, R304.5.1, R304.5.3	ı		
	I		
	I
