# Access Compliance Report

## Public Rights-of-Way

### (Curb Ramps)

Intersection ID: 50241	Main Street: EVERGREEN TERRACE DR	Cross Street: CEDAR WALK LN	Location: NE
ADA ID: 0D29DDF4758D	Ramp Type: Perp	Initial Pass/Fail: Fail	Overall Compliance: No
Severity Score: 12.5			
Codes/Mitigation Info/Possible Solution		Field Measurements/Component Compliance

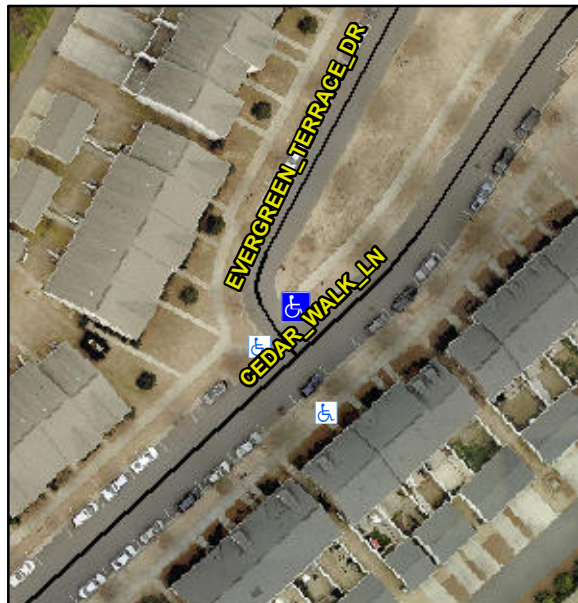
**Not Found, R304.2.2**

Compliance	Description	Data	Compliance	Description	Data
N/A	Ramp Length (in)	70.5	No	Ramp Slope (%)	10.2
Yes	Ramp Width (in)	48.5	Yes	Ramp XSlope (%)	0.2
N/A	Flare Type LT	N/A	N/A	Flare Type RT	N/A
N/A	Flare Slope LT (%)	N/A	N/A	Flare Slope RT (%)	N/A
N/A	Flare Traversable LT?	N/A	N/A	Flare Traversable RT?	N/A
N/A	Landing Length (in)	N/A	N/A	DWS Provided?	N/A
N/A	Landing Width (in)	N/A	N/A	DWS Contrast?	N/A
N/A	Landing Slope (%)	N/A	N/A	DWS Length (in)	N/A
N/A	Landing X Slope (%)	N/A	N/A	DWS Full Width?	N/A
N/A	Landing Curb? (Y/N)	N/A	N/A	DWS Offset (in)	N/A
N/A	Shared Landing?	N/A			
N/A	Gutter Ponding?	N/A	N/A	Gutter Slope (%)	N/A
N/A	Gutter Lip Ht (in)	N/A	N/A	Gutter X Slope (%)	N/A
N/A	Painted X Walk1?	No	N/A	Painted X Walk2?	N/A
	X Walk 1 Direction	To SW		X Walk 2 Direction	N/A
N/A	X Walk 1 Width (in)	N/A	N/A	X Walk 2 Width (in)	N/A
	X Walk 1 Slope (%)	0.1		X Walk 2 Slope (%)	N/A
	X Walk 1 X Slope (%)	0.1		X Walk 2 X Slope (%)	N/A

N/A	Ramp inside XWalk1?	N/A	N/A	Ramp inside XWalk2?	N/A
	Road Slope (%)	N/A	N/A	Clear Space?	N/A
	Road X Slope (%)	N/A	N/A	Clear Space to XWalk (in)	N/A
N/A	Any Obstructions?	N/A	N/A	Storm Grate/Utility Hazard?	N/A
	Obstruction Type			Storm Grate/Utility Type	
		N/A			N/A
			Yes	Surface Condition? (G/P)	Good

Possible Solutions:

**Remove & Replace Entire Ramp.**
