Access Compliance Report

Public Rights-of-Way

(Curb Ramps)

| Intersection ID: 10579 | Main Street: RUSH_AV | Cross Street: TUCKASEEGEE_RD | Location: NE |

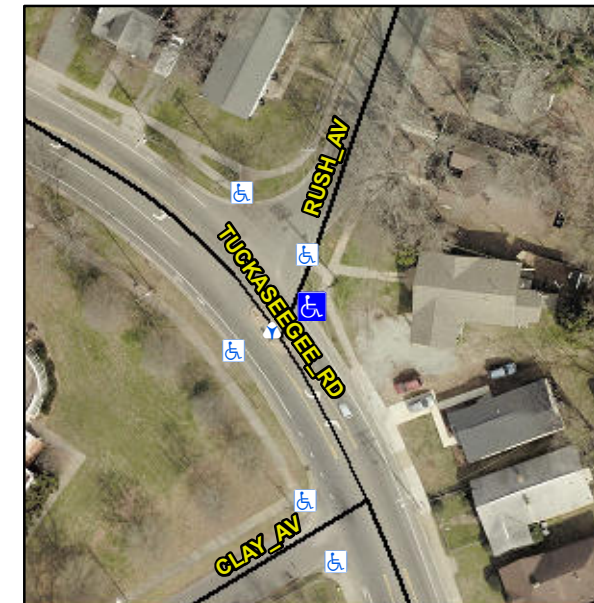
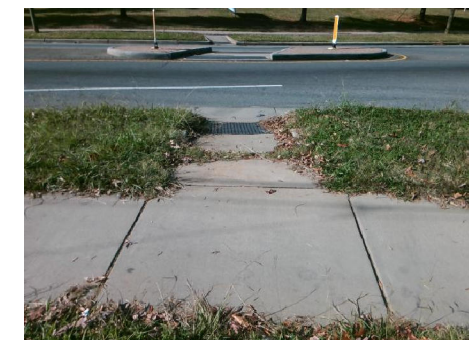
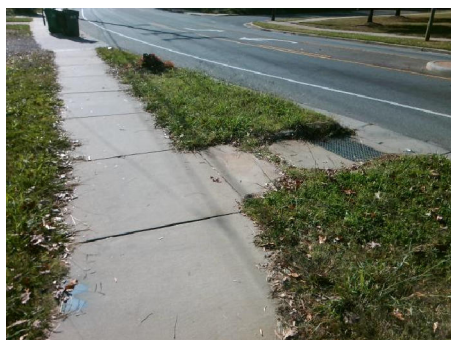
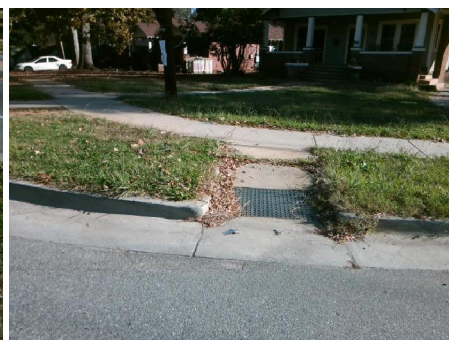
| ADA ID: 0D305CF8B244 | Ramp Type: Directional1 | Initial Pass/Fail: Fail | Overall Compliance: No |
| Severity Score: 21.25 | | | |

R304.5.1, R304.2.2

| Compliance | Description | Data | Compliance | Description | Data |
|---|---|---|---|---|---|
| No | Ramp Width (in) | 47.5 | N/A | Grade Break Slope (%) | 0.0 |
| No | Ramp Slope (%) | 8.4 | N/A | Grade Break XSlope (%) | 0.0 |

Remove & Replace Entire Ramp.

\$ 1600.00
