Access Compliance Report

Public Rights-of-Way

(Curb Ramps)

Intersection ID: 54779	Main Street: INDEPENDENCE/I-277_RA	Cross Street: N_SHARON_AMITY_RD	Location: NE
ADA ID: 0D3275BB1082	Ramp Type: Perp	Initial Pass/Fail: Fail	Overall Compliance: No
Severity Score: 12.5			
Codes/Mitigation Info/Possible Solution		Field Measurements/Component Compliance

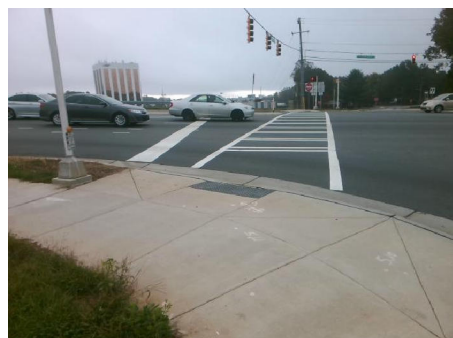
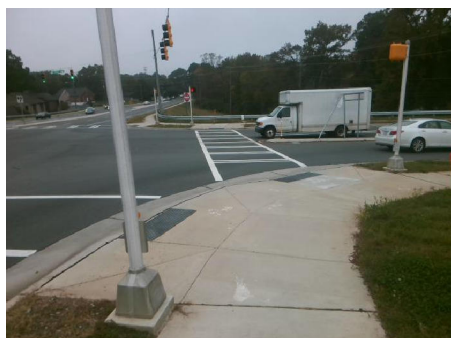
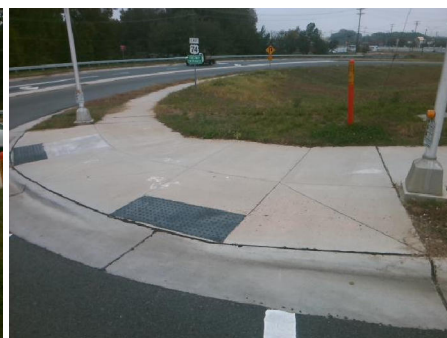
Compliance	Description	Data	Compliance	Description	Data
N/A	Ramp Length (in)	65.0	Yes	Ramp Slope (%)	5.8
Yes	Ramp Width (in)	59.0	No	Ramp XSlope (%)	5.2
N/A	Flare Type LT	N/A	N/A	Flare Type RT	N/A
N/A	Flare Slope LT (%)	N/A	N/A	Flare Slope RT (%)	N/A
N/A	Flare Traversable LT?	N/A	N/A	Flare Traversable RT?	N/A
N/A	Landing Length (in)	N/A	N/A	DWS Provided?	N/A
N/A	Landing Width (in)	N/A	N/A	DWS Contrast?	N/A
N/A	Landing Slope (%)	N/A	N/A	DWS Length (in)	N/A
N/A	Landing X Slope (%)	N/A	N/A	DWS Full Width?	N/A
N/A	Landing Curb? (Y/N)	N/A	N/A	DWS Offset (in)	N/A
N/A	Shared Landing?	N/A			
N/A	Gutter Ponding?	N/A	N/A	Gutter Slope (%)	N/A
N/A	Gutter Lip Ht (in)	N/A	N/A	Gutter X Slope (%)	N/A
N/A	Painted X Walk1?	Yes	N/A	Painted X Walk2?	N/A
	X Walk 1 Direction	To SE		X Walk 2 Direction	N/A
N/A	X Walk 1 Width (in)	112.0	N/A	X Walk 2 Width (in)	N/A
	X Walk 1 Slope (%)	2.7		X Walk 2 Slope (%)	N/A
	X Walk 1 X Slope (%)	6.3		X Walk 2 X Slope (%)	N/A

N/A	Ramp inside XWalk1?	Yes	N/A	Ramp inside XWalk2?	N/A
	Road Slope (%)	N/A	N/A	Clear Space?	N/A
	Road X Slope (%)	N/A	N/A	Clear Space to XWalk (in)	N/A
N/A	Any Obstructions?	N/A	N/A	Storm Grate/Utility Hazard?	N/A
	Obstruction Type			Storm Grate/Utility Type	
		N/A			N/A
		Yes		Surface Condition? (G/P)	Good

Possible Solutions:

Remove & Replace Entire Ramp.
