Access Compliance Report

Public Rights-of-Way

(Curb Ramps)

Intersection ID: 52893	Main Street: TWITTER_LN	Cross Street: SANCTUARY_PL	Location: SE
ADA ID: 0D33B9B9D43A	Ramp Type: Combination1	Initial Pass/Fail: Fail	Overall Compliance: No
			Severity Score: 21.25

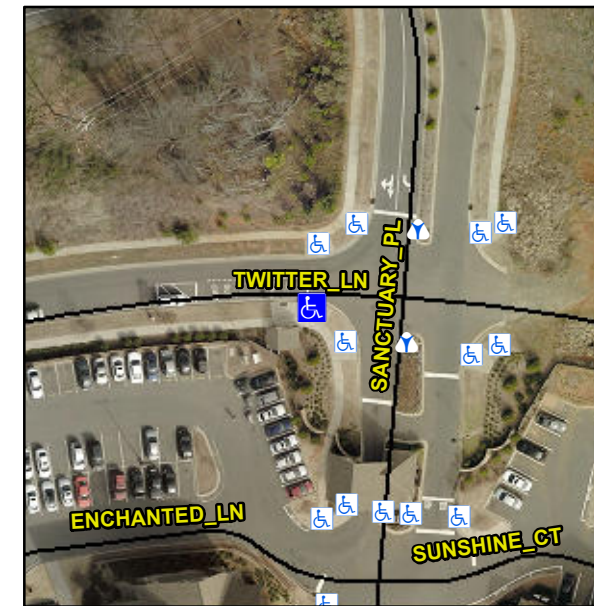
Not Found, R304.5.1, R304.5.3

Compliance	Description	Data	Compliance	Description	Data
N/A	Ramp Length LT (in)	30.5	N/A	Ramp Length RT (in)	49.5
Yes	Ramp Width LT (in)	59.5	Yes	Ramp Width RT (in)	62.0
Yes	Ramp Slope LT (%)	6.0	Yes	Ramp Slope RT (%)	7.7
Yes	Ramp XSlope LT (%)	0.6	Yes	Ramp XSlope RT (%)	0.9
N/A	Ramp Length (in)	101.0	Yes	Ramp Slope (%)	5.0
No	Ramp Width (in)	47.5	No	Ramp XSlope (%)	5.7
N/A	Flare Type LT	N/A	N/A	Flare Type RT	N/A
N/A	Flare Slope LT (%)	N/A	N/A	Flare Slope RT (%)	N/A
N/A	Flare Traversable LT?	N/A	N/A	Flare Traversable RT?	N/A
N/A	Landing Length (in)	N/A	N/A	DWS Provided?	N/A
N/A	Landing Width (in)	N/A	N/A	DWS Contrast?	N/A
N/A	Landing Slope (%)	N/A	N/A	DWS Length (in)	N/A
N/A	Landing X Slope (%)	N/A	N/A	DWS Full Width?	N/A
N/A	Landing Curb? (Y/N)	N/A	N/A	DWS Offset (in)	N/A
N/A	Shared Landing?	N/A			
N/A	Gutter Ponding?	N/A	N/A	Gutter Slope (%)	N/A
N/A	Gutter Lip Ht (in)	N/A	N/A	Gutter X Slope (%)	N/A
N/A	Painted X Walk1?	No	N/A	Painted X Walk2?	N/A

X Walk 1 Direction	To N		X Walk 2 Direction	N/A
	X Walk 1 Width (in)	N/A		X Walk 2 Width (in)	N/A
	X Walk 1 Slope (%)	6.2		X Walk 2 Slope (%)	N/A
	X Walk 1 X Slope (%)	3.6		X Walk 2 X Slope (%)	N/A
N/A	Ramp inside XWalk1?	N/A	N/A	Ramp inside XWalk2?	N/A
	Road Slope (%)	N/A		Clear Space?	N/A
	Road X Slope (%)	N/A	N/A	Clear Space to XWalk (in)	N/A
			N/A	Any Obstruction?	N/A
				Obstruction Type	N/A
			N/A	Storm Grate/Utility Hazard?	N/A
				Storm Grate/Utility Type	N/A
Yes	Surface Condition? (G/P)	Good			
	Curb Slope (%)	28.4

Remove & Replace Entire Ramp.

Total Cost: \$ 1800.00
