Access Compliance Report

Public Rights-of-Way

(Curb Ramps)

Intersection ID: 27556	Main Street: LEDERER_AV	Cross Street: QUEARY_CT	Location: NE
ADA ID: 0D43B839FDA9	Ramp Type: Perp	Initial Pass/Fail: Fail	Overall Compliance: No
Severity Score: 12.5			
Codes/Mitigation Info/Possible Solution		Field Measurements/Component Compliance

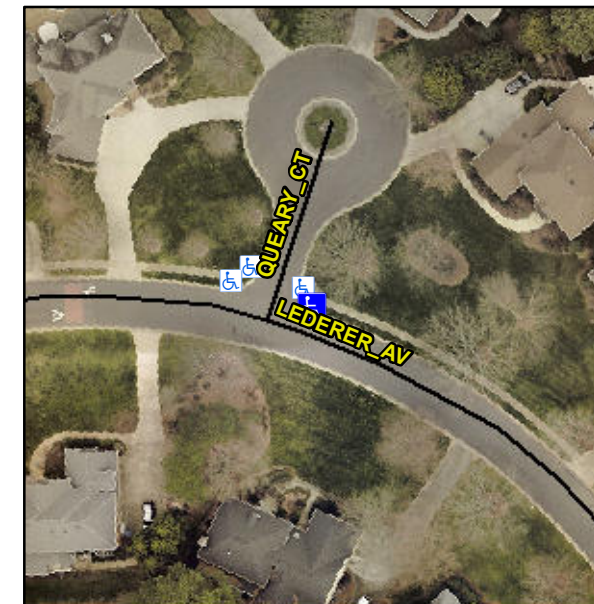
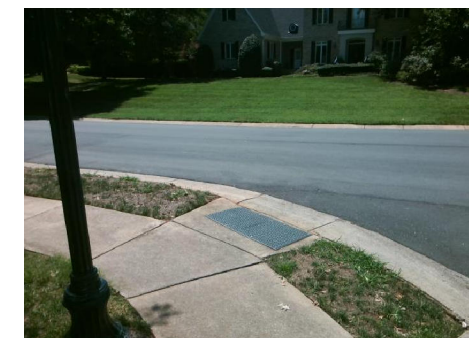
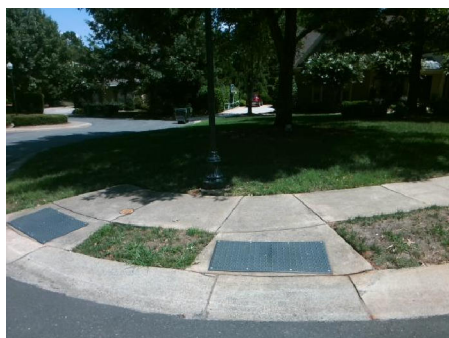
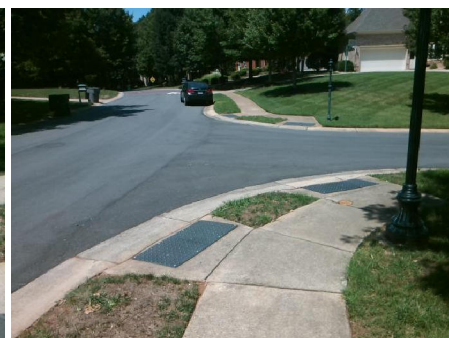
Compliance	Description	Data	Compliance	Description	Data
N/A	Ramp Length (in)	34.5	Yes	Ramp Slope (%)	7.7
Yes	Ramp Width (in)	48.0	No	Ramp XSlope (%)	5.4
N/A	Flare Type LT	N/A	N/A	Flare Type RT	N/A
N/A	Flare Slope LT (%)	N/A	N/A	Flare Slope RT (%)	N/A
N/A	Flare Traversable LT?	N/A	N/A	Flare Traversable RT?	N/A
N/A	Landing Length (in)	N/A	N/A	DWS Provided?	N/A
N/A	Landing Width (in)	N/A	N/A	DWS Contrast?	N/A
N/A	Landing Slope (%)	N/A	N/A	DWS Length (in)	N/A
N/A	Landing X Slope (%)	N/A	N/A	DWS Full Width?	N/A
N/A	Landing Curb? (Y/N)	N/A	N/A	DWS Offset (in)	N/A
N/A	Shared Landing?	N/A			
N/A	Gutter Ponding?	N/A	N/A	Gutter Slope (%)	N/A
N/A	Gutter Lip Ht (in)	N/A	N/A	Gutter X Slope (%)	N/A
N/A	Painted X Walk1?	No	N/A	Painted X Walk2?	N/A
	X Walk 1 Direction	To SW		X Walk 2 Direction	N/A
N/A	X Walk 1 Width (in)	N/A	N/A	X Walk 2 Width (in)	N/A
	X Walk 1 Slope (%)	3.3		X Walk 2 Slope (%)	N/A
	X Walk 1 X Slope (%)	1.3		X Walk 2 X Slope (%)	N/A

N/A	Ramp inside XWalk1?	N/A	N/A	Ramp inside XWalk2?	N/A
	Road Slope (%)	N/A	N/A	Clear Space?	N/A
	Road X Slope (%)	N/A	N/A	Clear Space to XWalk (in)	N/A
N/A	Any Obstructions?	N/A	N/A	Storm Grate/Utility Hazard?	N/A
	Obstruction Type			Storm Grate/Utility Type	
		N/A			N/A
			Yes	Surface Condition? (G/P)	Good

Possible Solutions:

Remove & Replace Entire Ramp.

R304.5.3
