# Access Compliance Report

## Public Rights-of-Way

| Intersection ID: 13468 | Main Street: W_PARK_AV | Cross Street: WICKFORD_PL | Location: S |
| ADA ID: 0D537F9DA63E | Ramp Type: Perp | Initial Pass/Fail: Pass | Overall Compliance: No |

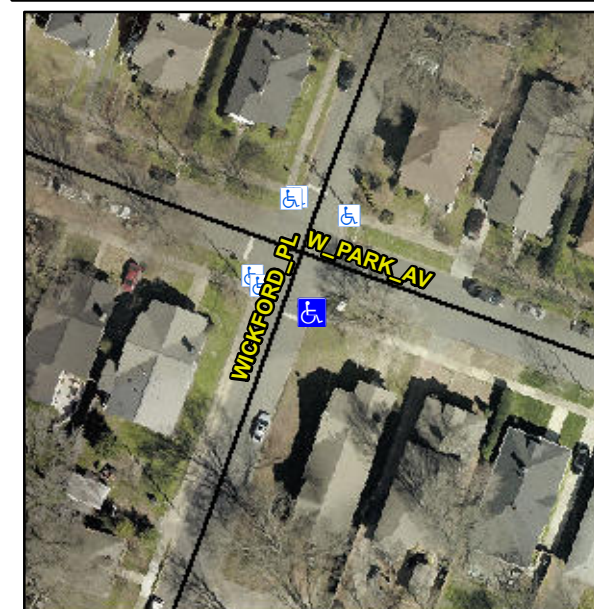
| Codes/Mitigation Info/Possible Solution | | | Severity Score: 25 |

**Not Found, R304.2.1, R304.2.2-Perp,  
R304.3.2-Para, R305, R302.7.2,  
R304.5.3**

| Compliance | Description | Data | Compliance | Description | Data |
|---|---|---|---|---|---|
| No | Landing Length (in) | 32.0 | No | DWS Provided? | No |
| No | Landing Slope (%) | 2.4 | N/A | DWS Length (in) | N/A |
| No | Gutter Lip Ht (in) | 3.0 | No | Gutter X Slope (%) | 2.1 |

**Remove & Replace Entire Ramp.  
Remove & Replace Gutter.**

Total Cost: \$ 2600.00

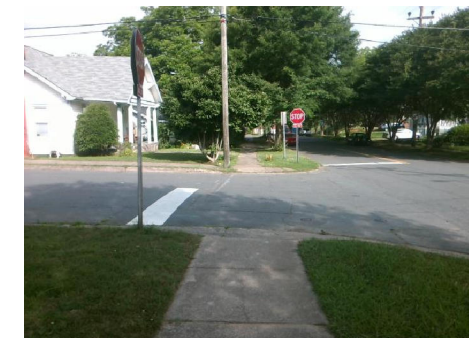
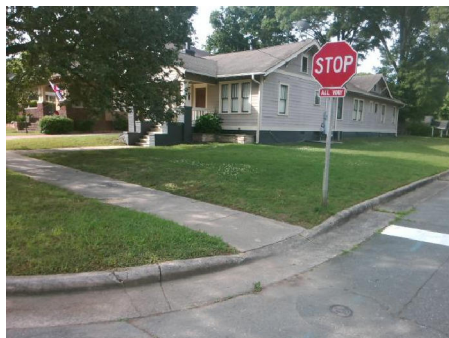
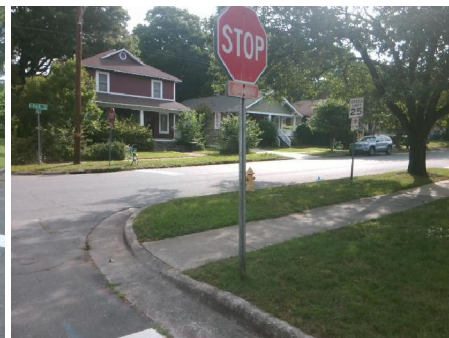
Street 1 Name WICKFORD PL  
Stop Condition-Street 2 StopSign  
Street 2 Name N/A  
Stop Condition-Street 1 N/A
