Access Compliance Report Public Rights-of-Way (Curb Ramps)

Intersection ID: 31460 Main Street: BOMAR DR Cross Street: HAMILTON OAKS DR Location: SW ADA ID: 0D546E0B258C Ramp Type: PerpDiag Initial Pass/Fail: Fail **Overall Compliance: No Severity Score:** 12.5

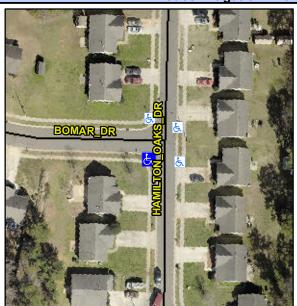
Field Measurements/Component Compliance						
Compliance Description		Data	Compliance		Description	Data
N/A	Ramp Length (in)	54.0	No	Ramp	Slope (%)	8.9
Yes	Ramp Width (in)	60.0	Yes	Ramp	XSlope (%)	1.4
N/A	Flare Type LT	N/A	N/A	Flare	Type RT	N/A
N/A	Flare Slope LT (%)	N/A	N/A	Flare	Slope RT (%)	N/A
N/A	Flare Traversable LT?	N/A	N/A	Flare	Traversable RT?	N/A
N/A	Landing Length (in)	N/A	N/A	DWS	Provided?	N/A
N/A	Landing Width (in)	N/A	N/A	DWS	Contrast?	N/A
N/A	Landing Slope (%)	N/A	N/A	DWS	Length (in)	N/A
N/A	Landing X Slope (%)	N/A	N/A	DWS	Full Width?	N/A
N/A	Landing Curb? (Y/N)	N/A	N/A	DWS	Offset (in)	N/A
N/A	Shared Landing?	N/A				
N/A	Gutter Ponding?	N/A	N/A	Gutte	r Slope (%)	N/A
N/A	Gutter Lip Ht (in)	N/A	N/A	Gutte	r X Slope (%)	N/A
N/A	Painted X Walk1?	No	N/A	Paint	ed X Walk2?	No
	X Walk 1 Direction	To SE		X Wa	lk 2 Direction	To NW
N/A	X Walk 1 Width (in)	N/A	N/A	X Wa	lk 2 Width (in)	N/A
	X Walk 1 Slope (%)	1.2		X Wa	lk 2 Slope (%)	2.1

X Walk 1 X Slope (%)	2.0		X Wa	lk 2 X Slope (%)	0.7
N/A	Ramp inside XWalk1?	N/A	N/A	Ram	inside XWalk2?	N/A
	Road Slope (%)	0.5	N/A	Clear	Space?	N/A
	Road X Slope (%)	3.1	N/A	Clear	Space to XWalk (in)	N/A
N/A	Any Obstructions?	N/A	N/A	Storn	n Grate/Utility Hazard?	N/A
	Obstruction Type			Storn	n Grate/Utility Type	
		N/A				N/A
			Yes	Surfa	ce Condition? (G/P)	Good

HAMILTON OAKS DR Street 1 Name Stop Condition-Street 2 None Street 2 Name **BOMAR DR** Stop Condition-Street 1 StopSign Possible Solutions: Remove & Replace Curb Ramp With Two New Directional Ramps or Equivalent. Surveyor Notes: N/A
