Access Compliance Report

Public Rights-of-Way

(Curb Ramps)

Intersection ID: 9348	Main Street: GUY_E_SUDDRETH_AV	Cross Street: RITCH_AV	Location: SW
ADA ID: 0D58F0CC88DD	Ramp Type: Perp	Initial Pass/Fail: Fail	Overall Compliance: No
Severity Score: 22.5			
Codes/Mitigation Info/Possible Solution		Field Measurements/Component Compliance

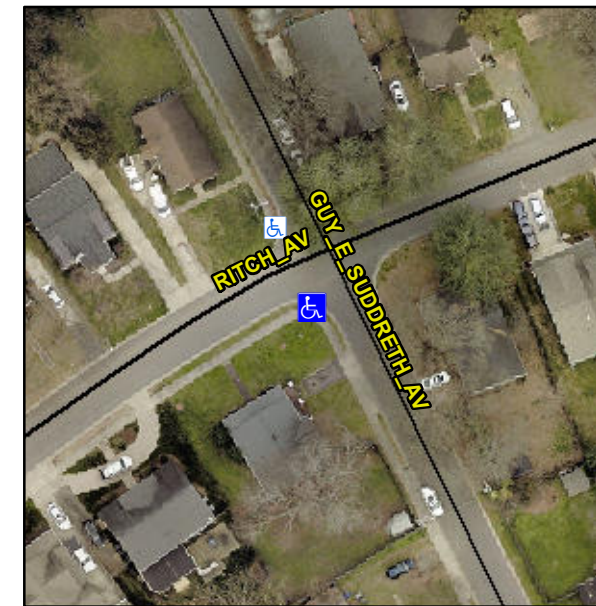
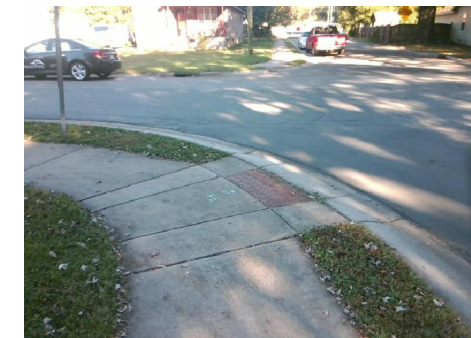
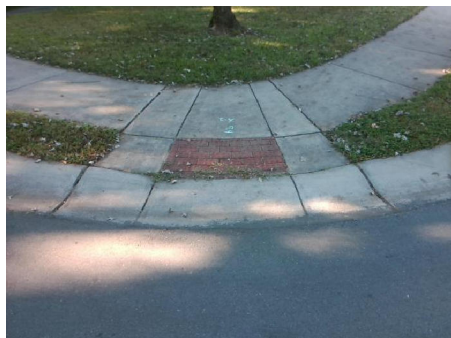
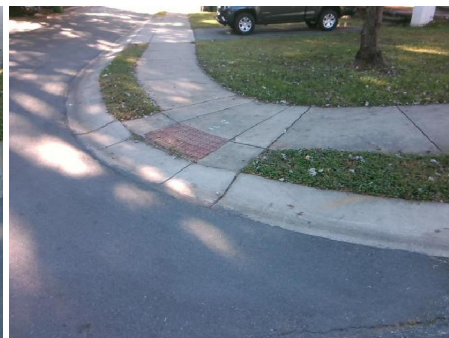
Not Found, R304.5.1, R304.2.2, R304.5.3

Compliance	Description	Data	Compliance	Description	Data
N/A	Ramp Length (in)	25.5	No	Ramp Slope (%)	9.4
No	Ramp Width (in)	39.0	No	Ramp XSlope (%)	2.4
N/A	Flare Type LT	N/A	N/A	Flare Type RT	N/A
N/A	Flare Slope LT (%)	N/A	N/A	Flare Slope RT (%)	N/A
N/A	Flare Traversable LT?	N/A	N/A	Flare Traversable RT?	N/A
N/A	Landing Length (in)	N/A	N/A	DWS Provided?	N/A
N/A	Landing Width (in)	N/A	N/A	DWS Contrast?	N/A
N/A	Landing Slope (%)	N/A	N/A	DWS Length (in)	N/A
N/A	Landing X Slope (%)	N/A	N/A	DWS Full Width?	N/A
N/A	Landing Curb? (Y/N)	N/A	N/A	DWS Offset (in)	N/A
N/A	Shared Landing?	N/A			
N/A	Gutter Ponding?	N/A	N/A	Gutter Slope (%)	N/A
N/A	Gutter Lip Ht (in)	N/A	N/A	Gutter X Slope (%)	N/A
N/A	Painted X Walk1?	No	N/A	Painted X Walk2?	N/A
	X Walk 1 Direction	To NW		X Walk 2 Direction	N/A
N/A	X Walk 1 Width (in)	N/A	N/A	X Walk 2 Width (in)	N/A
	X Walk 1 Slope (%)	3.3		X Walk 2 Slope (%)	N/A
	X Walk 1 X Slope (%)	1.6		X Walk 2 X Slope (%)	N/A

N/A	Ramp inside XWalk1?	N/A	N/A	Ramp inside XWalk2?	N/A
	Road Slope (%)	N/A	N/A	Clear Space?	N/A
	Road X Slope (%)	N/A	N/A	Clear Space to XWalk (in)	N/A
N/A	Any Obstructions?	N/A	N/A	Storm Grate/Utility Hazard?	N/A
	Obstruction Type			Storm Grate/Utility Type	
		N/A			N/A
			Yes	Surface Condition? (G/P)	Good

Possible Solutions:

Remove & Replace Entire Ramp.
