# Access Compliance Report

## Public Rights-of-Way

### (Curb Ramps)

| Intersection ID: 5708 | Main Street: PLEASANT GROVE RD | Cross Street: OAKDALE GREEN DR | Location: S |

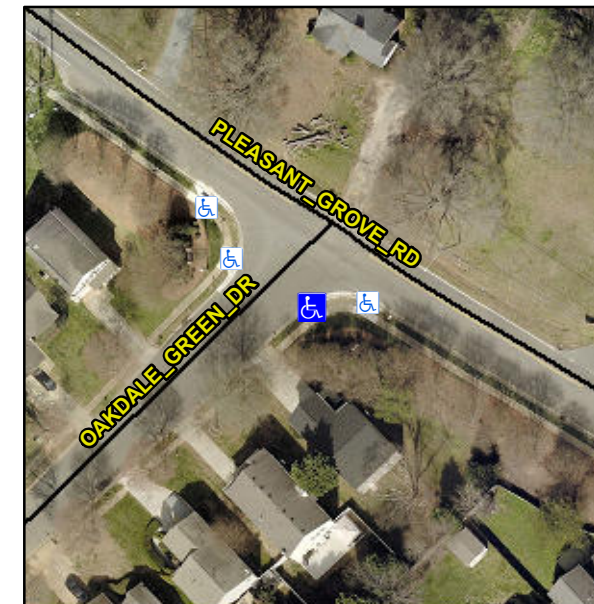
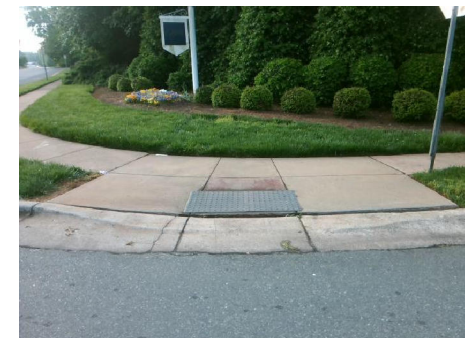
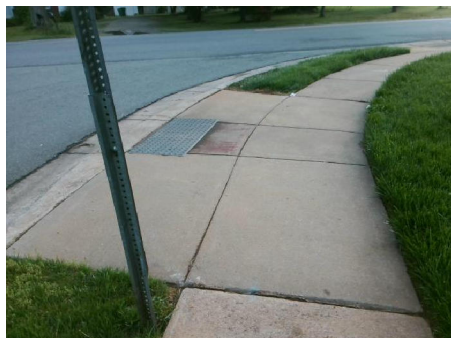
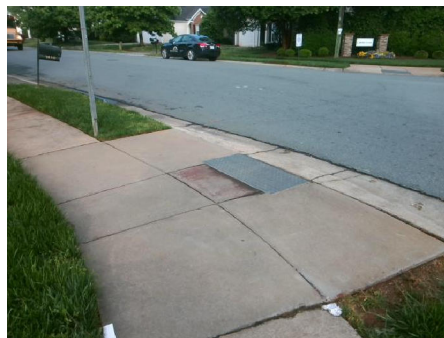
| ADA ID: 0D6065413A0B | Ramp Type: BlendTrans1 | Initial Pass/Fail: Fail | Overall Compliance: No |
| | | Severity Score: 8.75 | |

| Compliance | Description | Data | Compliance | Description | Data |
|---|---|---|---|---|---|
| N/A | Ramp Length (in) | 47.0 | Yes | BlendTrans Slope (%) | 0.9 |
| No | Ramp Width (in) | 39.0 | Yes | BlendTrans XSlope (%) | 0.3 |

**Remove & Replace Curb Ramp With Two New Directional Ramps or Equivalent.**

**R304.5.1**
