# Access Compliance Report

## Public Rights-of-Way

### (Curb Ramps)

Intersection ID: 31569	Main Street: ARVIN_DR	Cross Street: CROSS_ST	Location:	E
ADA ID: 0D66D8792839	Ramp Type: Perp	Initial Pass/Fail: Fail	Overall Compliance: No	Severity Score: 10

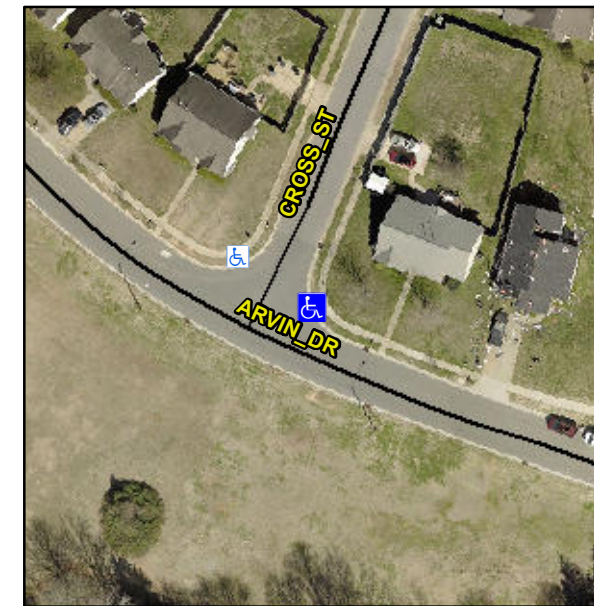
**Not Found, R304.5.1, R304.5.3**

Compliance	Description	Data	Compliance	Description	Data
N/A	Ramp Length (in)	48.0	Yes	Ramp Slope (%)	6.3
No	Ramp Width (in)	39.5	No	Ramp XSlope (%)	3.6
N/A	Flare Type LT	N/A	N/A	Flare Type RT	N/A
N/A	Flare Slope LT (%)	N/A	N/A	Flare Slope RT (%)	N/A
N/A	Flare Traversable LT?	N/A	N/A	Flare Traversable RT?	N/A
N/A	Landing Length (in)	N/A	N/A	DWS Provided?	N/A
N/A	Landing Width (in)	N/A	N/A	DWS Contrast?	N/A
N/A	Landing Slope (%)	N/A	N/A	DWS Length (in)	N/A
N/A	Landing X Slope (%)	N/A	N/A	DWS Full Width?	N/A
N/A	Landing Curb? (Y/N)	N/A	N/A	DWS Offset (in)	N/A
N/A	Shared Landing?	N/A			
N/A	Gutter Ponding?	N/A	N/A	Gutter Slope (%)	N/A
N/A	Gutter Lip Ht (in)	N/A	N/A	Gutter X Slope (%)	N/A
N/A	Painted X Walk1?	No	N/A	Painted X Walk2?	N/A
	X Walk 1 Direction	To NW		X Walk 2 Direction	N/A
N/A	X Walk 1 Width (in)	N/A	N/A	X Walk 2 Width (in)	N/A
	X Walk 1 Slope (%)	4.1		X Walk 2 Slope (%)	N/A
	X Walk 1 X Slope (%)	1.4		X Walk 2 X Slope (%)	N/A

N/A	Ramp inside XWalk1?	N/A	N/A	Ramp inside XWalk2?	N/A
	Road Slope (%)	N/A	N/A	Clear Space?	N/A
	Road X Slope (%)	N/A	N/A	Clear Space to XWalk (in)	N/A
N/A	Any Obstructions?	N/A	N/A	Storm Grate/Utility Hazard?	N/A
	Obstruction Type			Storm Grate/Utility Type	
		N/A			N/A
			Yes	Surface Condition? (G/P)	Good

**Remove & Replace Entire Ramp.**
