Access Compliance Report

Public Rights-of-Way

(Curb Ramps)

Intersection ID: 18848	Main Street: TYVOLA_RD	Cross Street: TYVOLA_RD	Location: SE
ADA ID: 0D66FB064E30	Ramp Type: Perp	Initial Pass/Fail: Fail	Overall Compliance: No
		Severity Score: 25

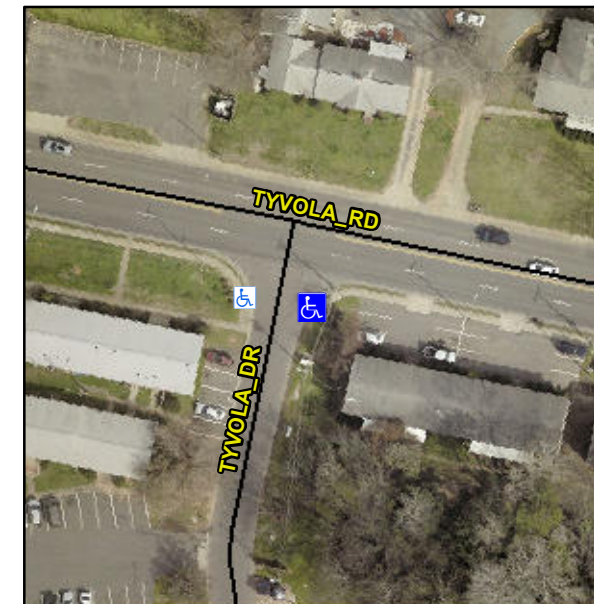
Not Found, R304.2.2, R304.5.3

Compliance	Description	Data	Compliance	Description	Data
N/A	Ramp Length (in)	69.0	No	Ramp Slope (%)	10.2
Yes	Ramp Width (in)	60.0	No	Ramp XSlope (%)	6.0
N/A	Flare Type LT	N/A	N/A	Flare Type RT	N/A
N/A	Flare Slope LT (%)	N/A	N/A	Flare Slope RT (%)	N/A
N/A	Flare Traversable LT?	N/A	N/A	Flare Traversable RT?	N/A
N/A	Landing Length (in)	N/A	N/A	DWS Provided?	N/A
N/A	Landing Width (in)	N/A	N/A	DWS Contrast?	N/A
N/A	Landing Slope (%)	N/A	N/A	DWS Length (in)	N/A
N/A	Landing X Slope (%)	N/A	N/A	DWS Full Width?	N/A
N/A	Landing Curb? (Y/N)	N/A	N/A	DWS Offset (in)	N/A
N/A	Shared Landing?	N/A			
N/A	Gutter Ponding?	N/A	N/A	Gutter Slope (%)	N/A
N/A	Gutter Lip Ht (in)	N/A	N/A	Gutter X Slope (%)	N/A
N/A	Painted X Walk1?	No	N/A	Painted X Walk2?	N/A
	X Walk 1 Direction	To NW		X Walk 2 Direction	N/A
N/A	X Walk 1 Width (in)	N/A	N/A	X Walk 2 Width (in)	N/A
	X Walk 1 Slope (%)	4.0		X Walk 2 Slope (%)	N/A
	X Walk 1 X Slope (%)	6.3		X Walk 2 X Slope (%)	N/A

N/A	Ramp inside XWalk1?	N/A	N/A	Ramp inside XWalk2?	N/A
	Road Slope (%)	N/A	N/A	Clear Space?	N/A
	Road X Slope (%)	N/A	N/A	Clear Space to XWalk (in)	N/A
N/A	Any Obstructions?	N/A	N/A	Storm Grate/Utility Hazard?	N/A
	Obstruction Type			Storm Grate/Utility Type	
		N/A			N/A
			Yes	Surface Condition? (G/P)	Good

Remove & Replace Entire Ramp.
