# Access Compliance Report

## Public Rights-of-Way

| Intersection ID: 15214 | Main Street: BRIARFIELD_DR | Cross Street: TARRINGTON_AV | Location: W |
| ADA ID: 0D6BB472B290 | Ramp Type: BlendTrans1 | Initial Pass/Fail: Fail | Overall Compliance: No |

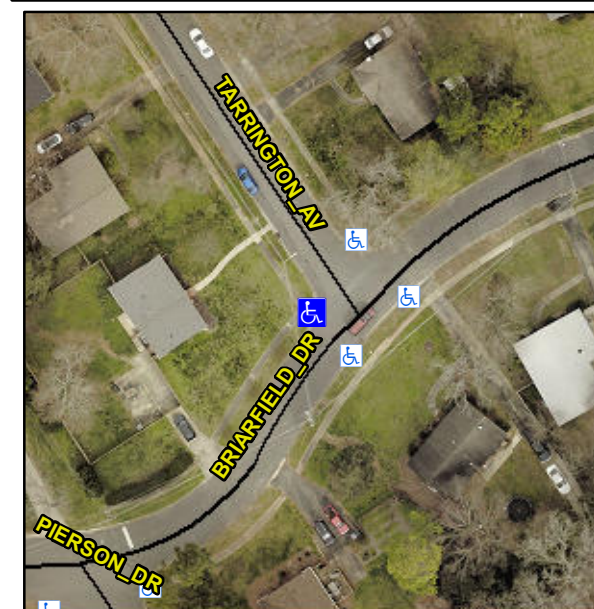
| Severity Score: 10 | | | |

**Not Found, R304.5.1, R304.5.3**

| Compliance | Description | Data | Compliance | Description | Data |
|---|---|---|---|---|---|
| No | Ramp Width (in) | 47.5 | No | BlendTrans XSlope (%) | 2.1 |

**Remove & Replace Curb Ramp With Two New Directional Ramps or Equivalent.**
