# Access Compliance Report

## Public Rights-of-Way

### (Curb Ramps)

Intersection ID: 52840	Main Street: MCKAY_RD	Cross Street: CRAVEN_THOMAS_RD	Location: NW
ADA ID: 0D6BD1F0E954	Ramp Type: Perp	Initial Pass/Fail: Fail	Overall Compliance: No
		Severity Score: 25

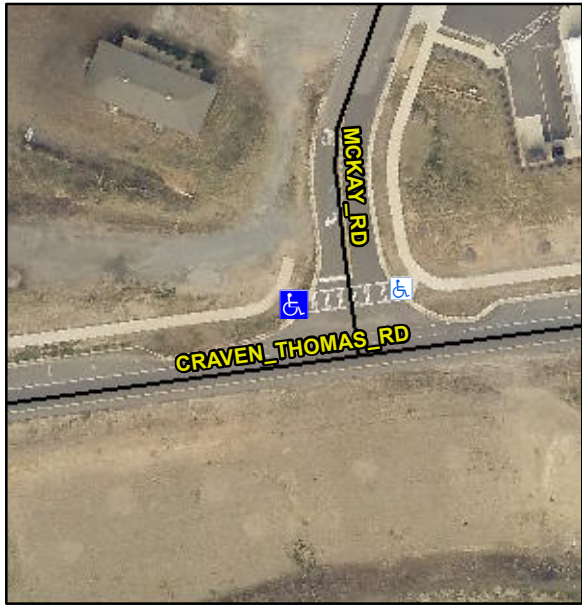
Possible Solutions:		<b>Compliance</b>	<b>Description</b>	<b>Data</b>	<b>Compliance</b>	<b>Description</b>	<b>Data</b>
	<b>Remove &amp; Replace Entire Ramp.</b>		N/A	Ramp Length (in)	131.5	No	Ramp Slope (%)	14.9
			Yes	Ramp Width (in)	48.5	Yes	Ramp XSlope (%)	0.5
			N/A	Flare Type LT	N/A	N/A	Flare Type RT	N/A
			N/A	Flare Slope LT (%)	N/A	N/A	Flare Slope RT (%)	N/A
			N/A	Flare Traversable LT?	N/A	N/A	Flare Traversable RT?	N/A
			N/A	Landing Length (in)	N/A	N/A	DWS Provided?	N/A
			N/A	Landing Width (in)	N/A	N/A	DWS Contrast?	N/A
			N/A	Landing Slope (%)	N/A	N/A	DWS Length (in)	N/A
			N/A	Landing X Slope (%)	N/A	N/A	DWS Full Width?	N/A
Surveyor Notes:			N/A	Landing Curb? (Y/N)	N/A	N/A	DWS Offset (in)	N/A
<b>N/A</b>			N/A	Shared Landing?	N/A			
PROW/ADA:			N/A	Gutter Ponding?	N/A	N/A	Gutter Slope (%)	N/A
<b>R304.2.2</b>			N/A	Gutter Lip Ht (in)	N/A	N/A	Gutter X Slope (%)	N/A
