# Access Compliance Report

## Public Rights-of-Way (Curb Ramps)

Intersection ID: 24621	Main Street: HUGH_FOREST_RD	Cross Street: WALTHAM_LN	Location: SW
ADA ID: 0D7A058CD290	Ramp Type: PerpDiag	Initial Pass/Fail: Fail	Overall Compliance: No
		Severity Score: 12.5

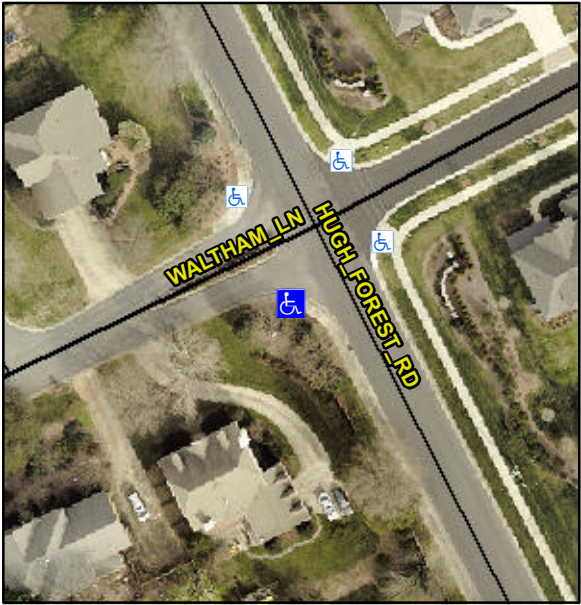
<p>Street 1 Name                      <b>HUGH FOREST RD</b></p> <p>Stop Condition-Street 2                      <b>None</b></p> <p>Street 2 Name                      <b>WALTHAM LN</b></p> <p>Stop Condition-Street 1                      <b>StopSign</b></p>	Possible Solutions:		<b>Compliance</b>	<b>Description</b>	<b>Data</b>
	<b>Remove &amp; Replace Curb Ramp With Two New Directional Ramps or Equivalent.</b>		<b>No</b>	Ramp Length (in)	<b>59.5</b>
			<b>Yes</b>	Ramp Width (in)	<b>48.0</b>
			<b>N/A</b>	Flare Type LT	<b>N/A</b>
			<b>N/A</b>	Flare Slope LT (%)	<b>N/A</b>
			<b>N/A</b>	Flare Traversable LT?	<b>N/A</b>
			<b>N/A</b>	Landing Length (in)	<b>N/A</b>
			<b>N/A</b>	Landing Width (in)	<b>N/A</b>
			<b>N/A</b>	Landing Slope (%)	<b>N/A</b>
			<b>N/A</b>	Landing X Slope (%)	<b>N/A</b>
			<b>N/A</b>	Landing Curb? (Y/N)	<b>N/A</b>

<b>N/A</b>	Shared Landing?	<b>N/A</b>
			<b>N/A</b>	Gutter Ponding?	<b>N/A</b>
			<b>N/A</b>	Gutter Lip Ht (in)	<b>N/A</b>
			<b>No</b>	Painted X Walk1?	<b>No</b>
			<b>To E</b>	X Walk 1 Direction	<b>To N</b>
			<b>N/A</b>	X Walk 1 Width (in)	<b>N/A</b>
			<b>1.5</b>	X Walk 1 Slope (%)	<b>2.4</b>
			<b>0.5</b>	X Walk 1 X Slope (%)	<b>2.4</b>
			<b>N/A</b>	Ramp inside XWalk1?	<b>N/A</b>
<p>Surveyor Notes:</p> <p><b>N/A</b></p> <p>PROW/ADA:</p> <p><b>Not Found, R304.2.2</b></p>			<b>N/A</b>	Ramp inside XWalk2?	<b>N/A</b>
			<b>2.4</b>	Road Slope (%)	<b>N/A</b>
			<b>1.7</b>	Road X Slope (%)	<b>N/A</b>
			<b>N/A</b>	Any Obstructions?	<b>N/A</b>
				Obstruction Type	
			<b>N/A</b>		<b>N/A</b>
			<b>Yes</b>	Surface Condition? (G/P)	<b>Good</b>
Total Cost:		\$ 3200.00
