Access Compliance Report Public Rights-of-Way (Curb Ramps)

Main Street: LAUREL_POINTE_WY Intersection ID: 23151 Cross Street: MOSS_RD Location: SW **Overall Compliance: No ADA ID: 0D7EEC75549B** Ramp Type: Perp Initial Pass/Fail: Fail **Severity Score:** 12.5

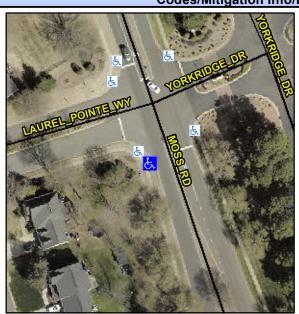
Field Measurements/Component Compliance								
Comp	liance Description	Data	Compli	ance	Description	Data		
N/A	Ramp Length (in)	127.0	No	Ramp	Slope (%)	9.2		
Yes	Ramp Width (in)	48.0	Yes	es Ramp XSlope (%)		1.0		
N/A	Flare Type LT	N/A	N/A	A Flare Type RT		N/A		
N/A	Flare Slope LT (%)	N/A	N/A	Flare Slope RT (%)		N/A		
N/A	Flare Traversable LT?	N/A	N/A	Flare Traversable RT?		N/A		
N/A	Landing Length (in)	N/A	N/A	DWS	Provided?	N/A		
N/A	Landing Width (in)	N/A	N/A	DWS	Contrast?	N/A		
N/A	Landing Slope (%)	N/A	N/A	DWS	Length (in)	N/A		
N/A	Landing X Slope (%)	N/A	N/A	DWS	Full Width?	N/A		
N/A	Landing Curb? (Y/N)	N/A	N/A	DWS	Offset (in)	N/A		
N/A	Shared Landing?	N/A						
N/A	Gutter Ponding?	N/A	N/A	Gutte	r Slope (%)	N/A		
N/A	Gutter Lip Ht (in)	N/A	N/A	Gutte	r X Slope (%)	N/A		
N/A	Painted X Walk1?	No	N/A	Paint	ed X Walk2?	N/A		
	X Walk 1 Direction	To NE		X Wa	lk 2 Direction	N/A		
N/A	X Walk 1 Width (in)	N/A	N/A	X Wa	lk 2 Width (in)	N/A

Possible Solutions:	Cor
Remove & Replace Entire Ramp.	N/A
·	Yes
	N/A
	N/A
	N/A
	N/A
Surveyor Notes:	N/A
N/A	N/A
	N/A
	N/A
	N/A
PROW/ADA:	N/A
Not Found, R304.2.2	N/A
	N/A
	N/A
	N/A
