Access Compliance Report Public Rights-of-Way (Curb Ramps)

Intersection ID: 12596Main Street:WILKINSON_BVCross Street:MONUMENT_STLocation:NEADA ID: 0D815953926ERamp Type:PerpInitial Pass/Fail:FailOverall Compliance:NoSeverity Score:33.75

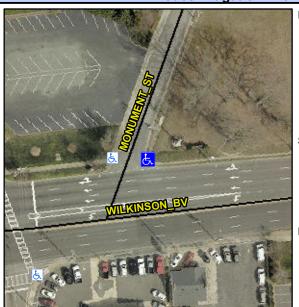
Comp	liance Description	Data	Comp	liance	Description	Data
N/A	Ramp Length (in)	62.5	No	Ramp	Slope (%)	11.1
No	Ramp Width (in)	38.5	No	Ramp	XSlope (%)	5.2
N/A	Flare Type LT	N/A	N/A	Flare	Type RT	N/A
N/A	Flare Slope LT (%)	N/A	N/A	Flare	Slope RT (%)	N/A
N/A	Flare Traversable LT?	N/A	N/A	Flare	Traversable RT?	N/A
N/A	Landing Length (in)	N/A	N/A	DWS	Provided?	N/A
N/A	Landing Width (in)	N/A	N/A	DWS	Contrast?	N/A
N/A	Landing Slope (%)	N/A	N/A	DWS	Length (in)	N/A
N/A	Landing X Slope (%)	N/A	N/A	DWS	Full Width?	N/A
N/A	Landing Curb? (Y/N)	N/A	N/A	DWS	Offset (in)	N/A
N/A	Shared Landing?	N/A				
N/A	Gutter Ponding?	N/A	N/A	Gutte	r Slope (%)	N/A
N/A	Gutter Lip Ht (in)	N/A	N/A	Gutte	r X Slope (%)	N/A
N/A	Painted X Walk1?	No	N/A	Paint	ed X Walk2?	N/A
	X Walk 1 Direction	To W		X Wa	lk 2 Direction	N/A
N/A	X Walk 1 Width (in)	N/A	N/A	X Wa	lk 2 Width (in)	N/A
	X Walk 1 Slope (%)	2.9		X Wa	lk 2 Slope (%)	N/A
	X Walk 1 X Slope (%)	4.2		X Wa	lk 2 X Slope (%)	N/A

N/A	Ramp inside XWalk1?	N/A	N/A	Ram	inside XWalk2?	N/A
	Road Slope (%)	N/A	N/A	Clear	Space?	N/A
	Road X Slope (%)	N/A	N/A	Clear	Space to XWalk (in)	N/A
N/A	Any Obstructions?	N/A	N/A	Storn	n Grate/Utility Hazard?	N/A
	Obstruction Type			Storn	n Grate/Utility Type	
		N/A				N/A
			Yes	Surfa	ce Condition? (G/P)	Good
W	A-

Danaikla Calutiana	0
Possible Solutions:	Comp
Remove & Replace Entire Ramp.	N/A
	No
	N/A
	N/A
	N/A
	N/A
Surveyor Notes:	N/A
N/A	N/A
	N/A
	N/A
	N/A
PROW/ADA:	N/A
Not Found, R304.5.1, R304.2.2,	N/A
R304.5.3	N/A
	N/A
	N/A
