Access Compliance Report

Public Rights-of-Way

(Curb Ramps)

Intersection ID: 10034377	Main Street: CAMERON_VALLEY_PY	Cross Street: PHILLIPS_PL	Location: NW
ADA ID: 0D8524B9BC3C	Ramp Type: BlendTrans1	Initial Pass/Fail: Fail	Overall Compliance: No
		Severity Score: 1.25

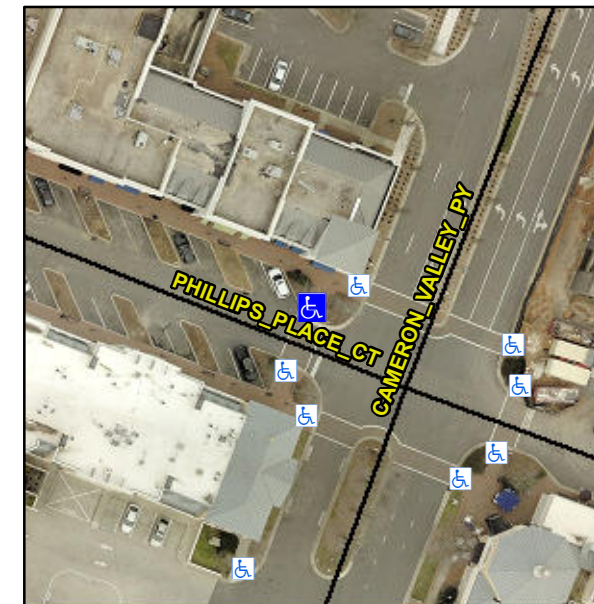
Compliance	Description	Data	Compliance	Description	Data
N/A	Ramp Length (in)	106.0	Yes	BlendTrans Slope (%)	2.3
Yes	Ramp Width (in)	172.0	No	BlendTrans XSlope (%)	4.0
N/A	Flare Type LT	N/A	N/A	Flare Type RT	N/A
N/A	Flare Slope LT (%)	N/A	N/A	Flare Slope RT (%)	N/A
N/A	Flare Traversable LT?	N/A	N/A	Flare Traversable RT?	N/A
N/A	Landing Length (in)	N/A	N/A	DWS Provided?	N/A
N/A	Landing Width (in)	N/A	N/A	DWS Contrast?	N/A
N/A	Landing Slope (%)	N/A	N/A	DWS Length (in)	N/A
N/A	Landing X Slope (%)	N/A	N/A	DWS Full Width?	N/A
N/A	Landing Curb? (Y/N)	N/A	N/A	DWS Offset (in)	N/A
N/A	Shared Landing?	N/A			
N/A	Gutter Ponding?	N/A	N/A	Gutter Slope (%)	N/A
N/A	Gutter Lip Ht (in)	N/A	N/A	Gutter X Slope (%)	N/A
N/A	Painted X Walk1?	Yes	N/A	Painted X Walk2?	N/A
	X Walk 1 Direction	To SW		X Walk 2 Direction	N/A
	X Walk 1 Width (in)	170.0		X Walk 2 Width (in)	N/A
	X Walk 1 Slope (%)	1.4		X Walk 2 Slope (%)	N/A
	X Walk 1 X Slope (%)	5.3		X Walk 2 X Slope (%)	N/A

N/A	Ramp inside XWalk1?	Yes	N/A	Ramp inside XWalk2?	N/A
	Road Slope (%)	5.3		Clear Space?	N/A
	Road X Slope (%)	1.4	N/A	Clear Space to XWalk (in)	N/A
N/A	Any Obstructions?	N/A	N/A	Storm Grate/Utility Hazard?	N/A
	Obstruction Type			Storm Grate/Utility Type	
		N/A			N/A
			Yes	Surface Condition? (G/P)	Good
			N/A	Curb Slope (%)	3.0

Possible Solutions:

Remove & Replace Curb Ramp With Two New Directional Ramps or Equivalent.

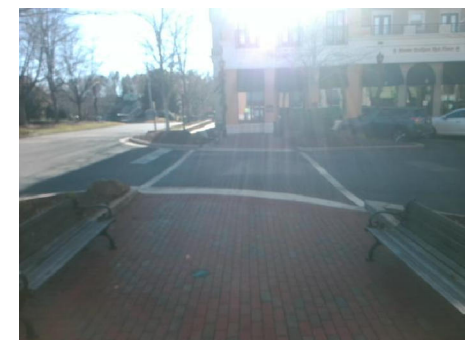
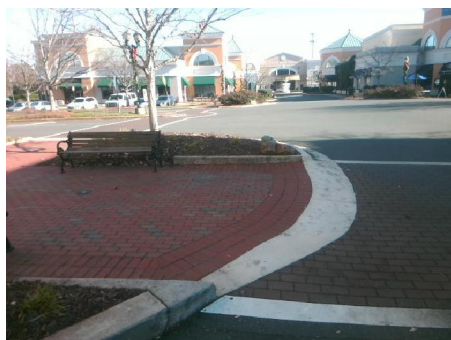
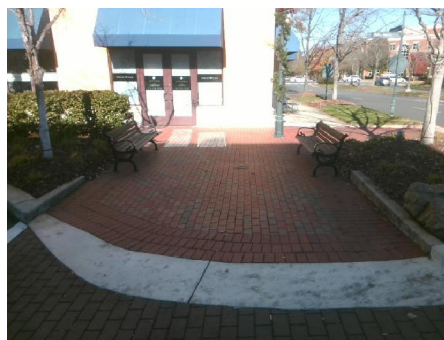
Surveyor Notes:

XWALK PAVERS
