# Access Compliance Report

## Public Rights-of-Way

### (Curb Ramps)

Intersection ID: 49396	Main Street: BARROSO_LN	Cross Street: ROMANA_RED_LN	Location: SW
ADA ID: 0D86641B6FEB	Ramp Type: Perp	Initial Pass/Fail: Fail	Overall Compliance: No
Severity Score: 22.5			
Codes/Mitigation Info/Possible Solution		Field Measurements/Component Compliance

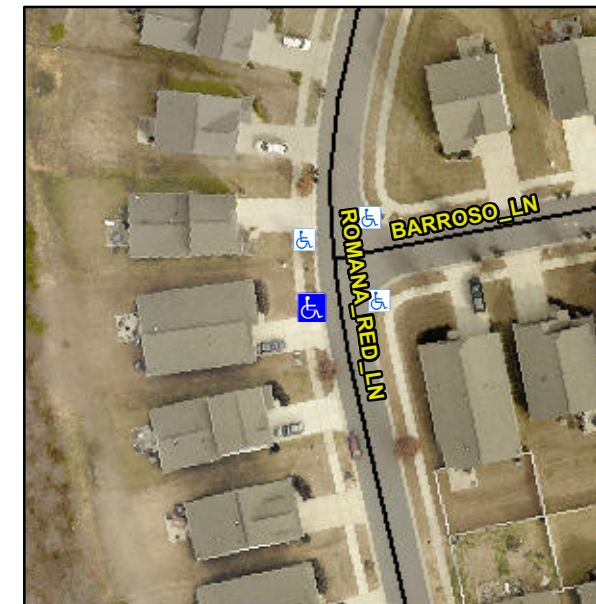
**Not Found, R304.5.1, R304.2.2**

Compliance	Description	Data	Compliance	Description	Data
N/A	Ramp Length (in)	70.5	No	Ramp Slope (%)	9.1
No	Ramp Width (in)	45.0	Yes	Ramp XSlope (%)	3.2
N/A	Flare Type LT	N/A	N/A	Flare Type RT	N/A
N/A	Flare Slope LT (%)	N/A	N/A	Flare Slope RT (%)	N/A
N/A	Flare Traversable LT?	N/A	N/A	Flare Traversable RT?	N/A
N/A	Landing Length (in)	N/A	N/A	DWS Provided?	N/A
N/A	Landing Width (in)	N/A	N/A	DWS Contrast?	N/A
N/A	Landing Slope (%)	N/A	N/A	DWS Length (in)	N/A
N/A	Landing X Slope (%)	N/A	N/A	DWS Full Width?	N/A
N/A	Landing Curb? (Y/N)	N/A	N/A	DWS Offset (in)	N/A
N/A	Shared Landing?	N/A			
N/A	Gutter Ponding?	N/A	N/A	Gutter Slope (%)	N/A
N/A	Gutter Lip Ht (in)	1.0	N/A	Gutter X Slope (%)	N/A
N/A	Painted X Walk1?	No	N/A	Painted X Walk2?	N/A
	X Walk 1 Direction	To E		X Walk 2 Direction	N/A
N/A	X Walk 1 Width (in)	N/A	N/A	X Walk 2 Width (in)	N/A
	X Walk 1 Slope (%)	1.5		X Walk 2 Slope (%)	N/A
	X Walk 1 X Slope (%)	3.8		X Walk 2 X Slope (%)	N/A

N/A	Ramp inside XWalk1?	N/A	N/A	Ramp inside XWalk2?	N/A
	Road Slope (%)	N/A	N/A	Clear Space?	N/A
	Road X Slope (%)	N/A	N/A	Clear Space to XWalk (in)	N/A
N/A	Any Obstructions?	N/A	N/A	Storm Grate/Utility Hazard?	N/A
	Obstruction Type			Storm Grate/Utility Type	
		N/A			N/A
			Yes	Surface Condition? (G/P)	Good

**Remove & Replace Entire Ramp.**
