# Access Compliance Report

## Public Rights-of-Way

### (Curb Ramps)

Intersection ID: 2609	Main Street: ANZACK_LN	Cross Street: HARTFIELD_DOWNS_DR	Location: NW
ADA ID: 0D8793173269	Ramp Type: Perp	Initial Pass/Fail: Fail	Overall Compliance: No
Severity Score: 37.5			
Codes/Mitigation Info/Possible Solution		Field Measurements/Component Compliance

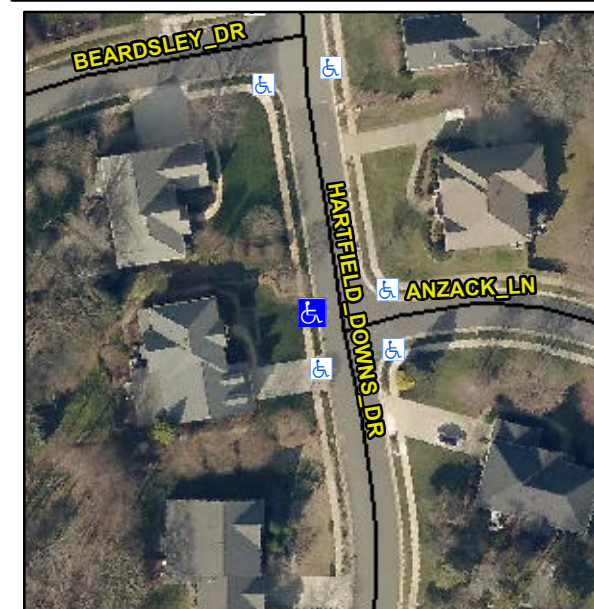
**Not Found, R304.2.2, R304.5.3**

Compliance	Description	Data	Compliance	Description	Data
N/A	Ramp Length (in)	46.0	No	Ramp Slope (%)	15.0
Yes	Ramp Width (in)	48.0	No	Ramp XSlope (%)	6.4
N/A	Flare Type LT	N/A	N/A	Flare Type RT	N/A
N/A	Flare Slope LT (%)	N/A	N/A	Flare Slope RT (%)	N/A
N/A	Flare Traversable LT?	N/A	N/A	Flare Traversable RT?	N/A
N/A	Landing Length (in)	N/A	N/A	DWS Provided?	N/A
N/A	Landing Width (in)	N/A	N/A	DWS Contrast?	N/A
N/A	Landing Slope (%)	N/A	N/A	DWS Length (in)	N/A
N/A	Landing X Slope (%)	N/A	N/A	DWS Full Width?	N/A
N/A	Landing Curb? (Y/N)	N/A	N/A	DWS Offset (in)	N/A
N/A	Shared Landing?	N/A			
N/A	Gutter Ponding?	N/A	N/A	Gutter Slope (%)	N/A
N/A	Gutter Lip Ht (in)	N/A	N/A	Gutter X Slope (%)	N/A
N/A	Painted X Walk1?	No	N/A	Painted X Walk2?	N/A
	X Walk 1 Direction	To E		X Walk 2 Direction	N/A
N/A	X Walk 1 Width (in)	N/A	N/A	X Walk 2 Width (in)	N/A
	X Walk 1 Slope (%)	1.7		X Walk 2 Slope (%)	N/A
	X Walk 1 X Slope (%)	7.3		X Walk 2 X Slope (%)	N/A

N/A	Ramp inside XWalk1?	N/A	N/A	Ramp inside XWalk2?	N/A
	Road Slope (%)	N/A	N/A	Clear Space?	N/A
	Road X Slope (%)	N/A	N/A	Clear Space to XWalk (in)	N/A
N/A	Any Obstructions?	N/A	N/A	Storm Grate/Utility Hazard?	N/A
	Obstruction Type			Storm Grate/Utility Type	
		N/A			N/A
			Yes	Surface Condition? (G/P)	Good

**Remove & Replace Entire Ramp.**

Total Cost: \$ 1850.00
