Access Compliance Report

Public Rights-of-Way

(Curb Ramps)

| Intersection ID: 17621 | Main Street: CROYDON_RD | Cross Street: RIDGEWOOD_AV | Location: SW |

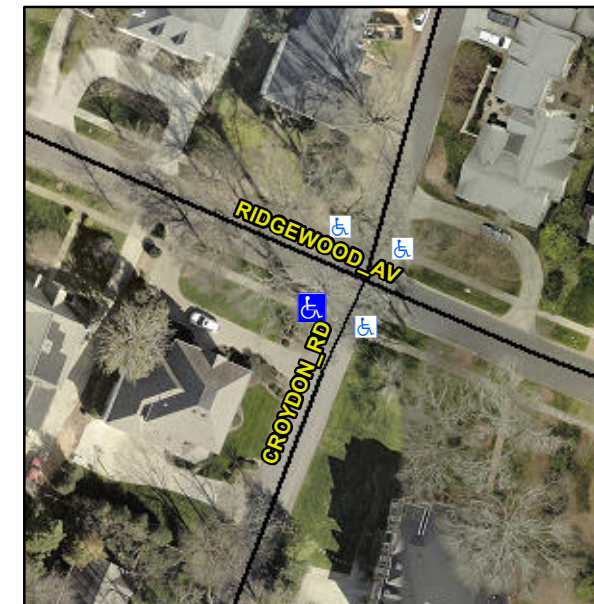
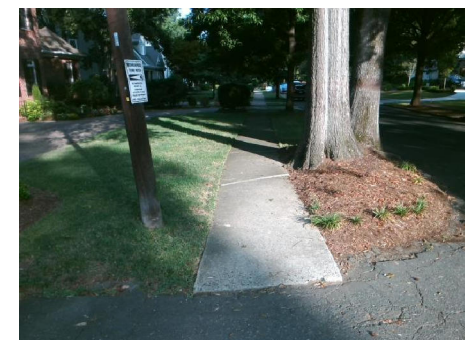
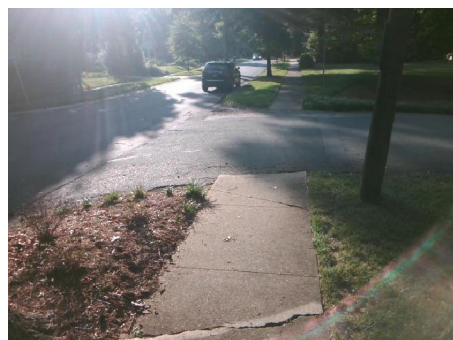
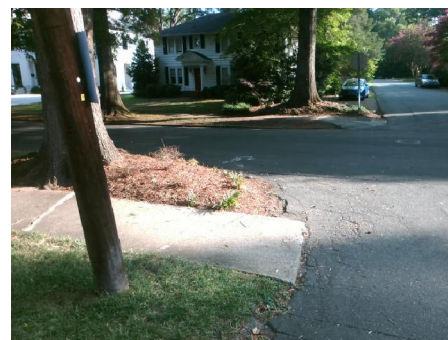
| ADA ID: 0D9DDEA71913 | Ramp Type: BlendTrans2 | Initial Pass/Fail: Fail | Overall Compliance: No |

NO CURB

R304.5.3

| Compliance | Description | Data | Compliance | Description | Data |
|---|---|---|---|---|---|
| Yes | Ramp Width (in) | 53.0 | No | BlendTrans XSlope (%) | 3.1 |

Remove & Replace Curb Ramp With Two New Directional Ramps or Equivalent.
