# Access Compliance Report

## Public Rights-of-Way (Curb Ramps)

| Intersection ID: 12244 | Main Street: BELMONT_AV | Cross Street: HARRILL_ST | Location: N |
| ADA ID: 0DA11570210A | Ramp Type: Directional1 | Initial Pass/Fail: Pass | Overall Compliance: No |

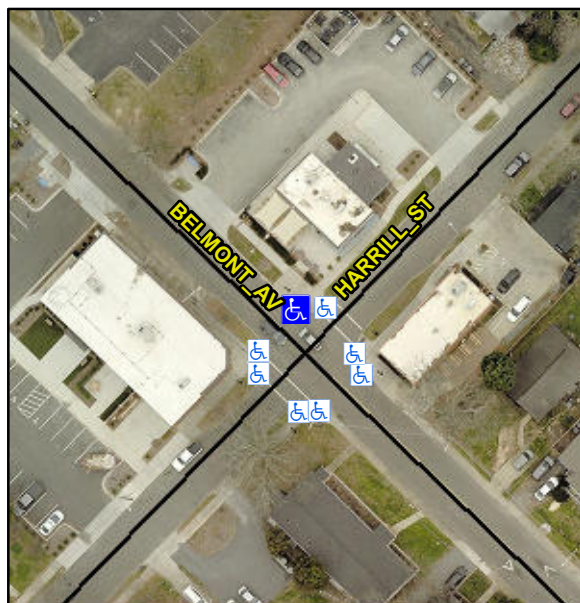
| Severity Score: 5.25 | | | |

**R304.2.2-Perp, R304.3.2-Para,  
R304.5.3, R304.2.3**

| Compliance | Description | Data | Compliance | Description | Data |
|---|---|---|---|---|---|
| No | Landing Slope (%) | 4.0 | Yes | DWS Length (in) | 24.0 |
| No | Landing X Slope (%) | 4.3 | Yes | DWS Full Width? | Yes |

**Remove & Replace Entire Ramp.**
