# Access Compliance Report

## Public Rights-of-Way

### (Curb Ramps)

Intersection ID: 54217	Main Street: GOLF_LINKS_DR	Cross Street: MIDWAY_PARK_DR	Location: SE
ADA ID: 0DA1AC644DA2	Ramp Type: Perp	Initial Pass/Fail: Fail	Overall Compliance: No
		Severity Score: 1.25

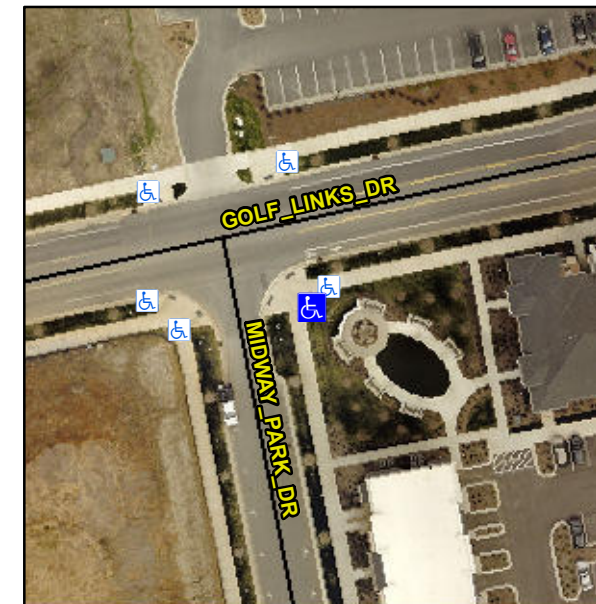
Compliance	Description	Data	Compliance	Description	Data
N/A	Ramp Length (in)	142.0	Yes	Ramp Slope (%)	8.1
Yes	Ramp Width (in)	59.0	No	Ramp XSlope (%)	3.6
N/A	Flare Type LT	N/A	N/A	Flare Type RT	N/A
N/A	Flare Slope LT (%)	N/A	N/A	Flare Slope RT (%)	N/A
N/A	Flare Traversable LT?	N/A	N/A	Flare Traversable RT?	N/A
N/A	Landing Length (in)	N/A	N/A	DWS Provided?	N/A
N/A	Landing Width (in)	N/A	N/A	DWS Contrast?	N/A
N/A	Landing Slope (%)	N/A	N/A	DWS Length (in)	N/A
N/A	Landing X Slope (%)	N/A	N/A	DWS Full Width?	N/A
N/A	Landing Curb? (Y/N)	N/A	N/A	DWS Offset (in)	N/A
N/A	Shared Landing?	N/A			
N/A	Gutter Ponding?	N/A	N/A	Gutter Slope (%)	N/A
N/A	Gutter Lip Ht (in)	N/A	N/A	Gutter X Slope (%)	N/A
N/A	Painted X Walk1?	No	N/A	Painted X Walk2?	N/A
	X Walk 1 Direction	To W		X Walk 2 Direction	N/A
N/A	X Walk 1 Width (in)	N/A	N/A	X Walk 2 Width (in)	N/A
	X Walk 1 Slope (%)	1.1		X Walk 2 Slope (%)	N/A
	X Walk 1 X Slope (%)	3.4		X Walk 2 X Slope (%)	N/A

N/A	Ramp inside XWalk1?	N/A	N/A	Ramp inside XWalk2?	N/A
	Road Slope (%)	N/A	N/A	Clear Space?	N/A
	Road X Slope (%)	N/A	N/A	Clear Space to XWalk (in)	N/A
N/A	Any Obstructions?	N/A	N/A	Storm Grate/Utility Hazard?	N/A
	Obstruction Type			Storm Grate/Utility Type	
		N/A			N/A
			Yes	Surface Condition? (G/P)	Good

**Remove & Replace Entire Ramp.**
