Access Compliance Report

Public Rights-of-Way

(Curb Ramps)

Intersection ID: 19953	Main Street: ARCHDALE_DR	Cross Street: OLD_PINEVILLE_RD	Location: SE
ADA ID: 0DA3B7B83DE1	Ramp Type: IslandPerp	Initial Pass/Fail: Fail	Overall Compliance: No
		Severity Score: 13.75

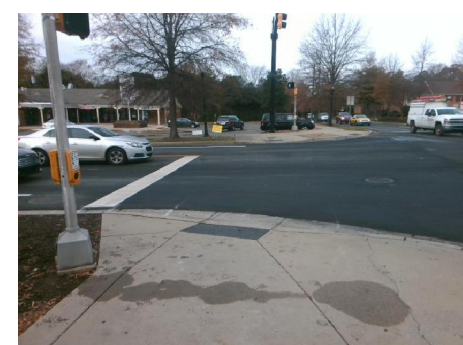
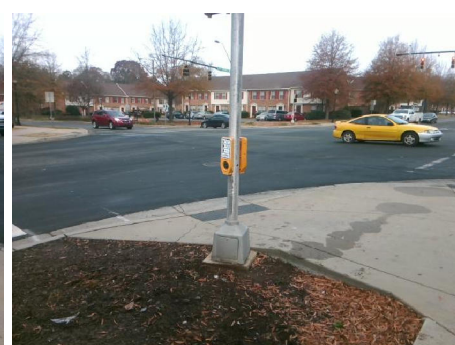
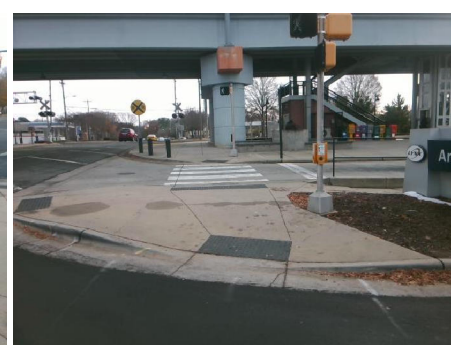
Possible Solutions:		Compliance	Description	Data
	Remove & Replace Entire Ramp.		No	Ramp Length (in)	80.0
			Yes	Ramp Width (in)	59.0
			N/A	Flare Type LT	N/A
			N/A	Flare Slope LT (%)	N/A
			N/A	Flare Traversable LT?	N/A
			N/A	Landing Length (in)	N/A
			N/A	Landing Width (in)	N/A
			N/A	Landing Slope (%)	N/A
			N/A	Landing X Slope (%)	N/A
<p>Surveyor Notes:</p> <p>N/A</p> <p>PROW/ADA:</p> <p>Not Found, R304.2.2, R304.5.3</p>			N/A	Flare Type RT	N/A
			N/A	Flare Slope RT (%)	N/A
			N/A	Flare Traversable RT?	N/A
			N/A	DWS Provided?	N/A
			N/A	DWS Contrast?	N/A
			N/A	DWS Length (in)	N/A
			N/A	DWS Full Width?	N/A
			N/A	DWS Offset (in)	N/A
			N/A	Gutter Ponding?	N/A
			N/A	Gutter Lip Ht (in)	N/A
			No	Painted X Walk1?	N/A
				X Walk 1 Direction	To W
			N/A	X Walk 1 Width (in)	N/A
				X Walk 1 Slope (%)	1.3
				X Walk 1 X Slope (%)	4.0

N/A	Ramp inside XWalk1?	N/A
			N/A	Road Slope (%)	N/A
			N/A	Road X Slope (%)	N/A
			N/A	Any Obstructions?	N/A
				Obstruction Type	
Total Cost:		\$ 3400.00	N/A	Storm Grate/Utility Hazard?	N/A
			N/A	Storm Grate/Utility Type	N/A
			Yes	Surface Condition? (G/P)	Good
