Access Compliance Report

Public Rights-of-Way

(Curb Ramps)

Intersection ID: 8578	Main Street: DARE_DR	Cross Street: HYDE_DR	Location: SE
ADA ID: 0DAE9FBFDE4E	Ramp Type: Perp	Initial Pass/Fail: Fail	Overall Compliance: No
		Severity Score: 10

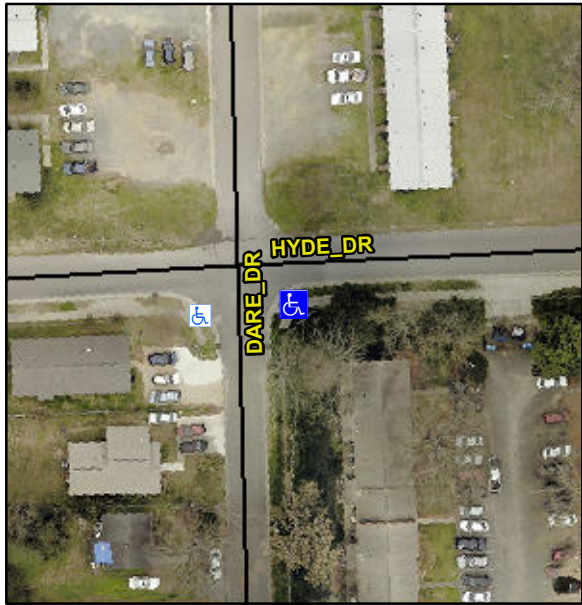
Possible Solutions:		Compliance	Description	Data	Compliance	Description	Data
	Remove & Replace Entire Ramp.		N/A	Ramp Length (in)	70.0	Yes	Ramp Slope (%)	8.3
			No	Ramp Width (in)	47.5	No	Ramp XSlope (%)	2.5
			N/A	Flare Type LT	N/A	N/A	Flare Type RT	N/A
			N/A	Flare Slope LT (%)	N/A	N/A	Flare Slope RT (%)	N/A
			N/A	Flare Traversable LT?	N/A	N/A	Flare Traversable RT?	N/A
			N/A	Landing Length (in)	N/A	N/A	DWS Provided?	N/A
			N/A	Landing Width (in)	N/A	N/A	DWS Contrast?	N/A
			N/A	Landing Slope (%)	N/A	N/A	DWS Length (in)	N/A
			N/A	Landing X Slope (%)	N/A	N/A	DWS Full Width?	N/A
<p>Surveyor Notes:</p> <p>N/A</p> <p>PROW/ADA:</p> <p>Not Found, R304.5.1, R304.5.3</p>			N/A	Landing Curb? (Y/N)	N/A	N/A	DWS Offset (in)	N/A
			N/A	Shared Landing?	N/A			
			N/A	Gutter Ponding?	N/A	N/A	Gutter Slope (%)	N/A
			N/A	Gutter Lip Ht (in)	N/A	N/A	Gutter X Slope (%)	N/A

N/A	Painted X Walk1?	No	N/A	Painted X Walk2?	N/A
				X Walk 1 Direction	To W		X Walk 2 Direction	N/A
			N/A	X Walk 1 Width (in)	N/A	N/A	X Walk 2 Width (in)	N/A
				X Walk 1 Slope (%)	0.5		X Walk 2 Slope (%)	N/A
				X Walk 1 X Slope (%)	1.3		X Walk 2 X Slope (%)	N/A
			N/A	Ramp inside XWalk1?	N/A	N/A	Ramp inside XWalk2?	N/A
			Road Slope (%)	N/A	N/A	Clear Space?	N/A	
			Road X Slope (%)	N/A	N/A	Clear Space to XWalk (in)	N/A	
		N/A	Any Obstructions?	N/A	N/A	Storm Grate/Utility Hazard?	N/A	
			Obstruction Type			Storm Grate/Utility Type		
					N/A			N/A
						Yes	Surface Condition? (G/P)	Good
Total Cost:		\$	1850.00
