# Access Compliance Report

## Public Rights-of-Way

### (Curb Ramps)

| Intersection ID: 28015 | Main Street: LANCASTER_HY | Cross Street: PROVIDENCE_RD_WEST | Location: SW |

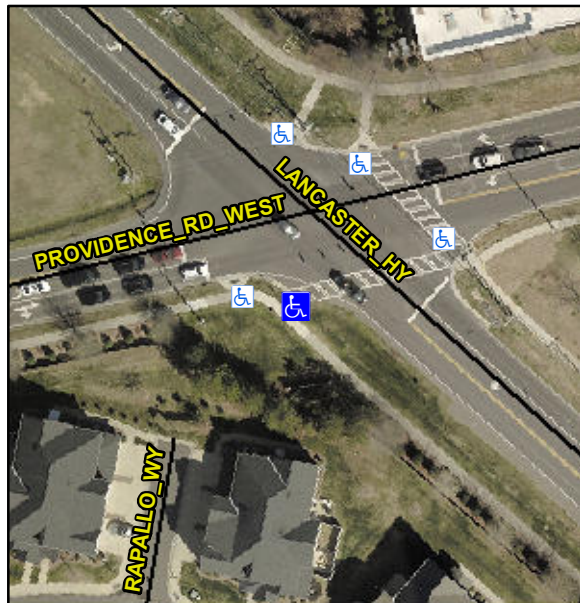
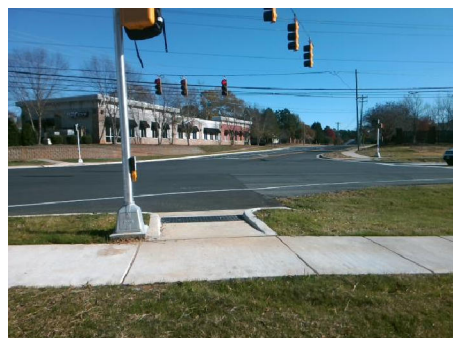
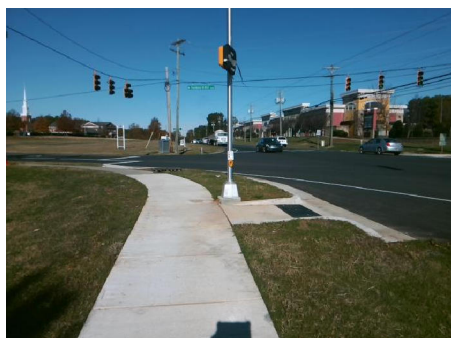
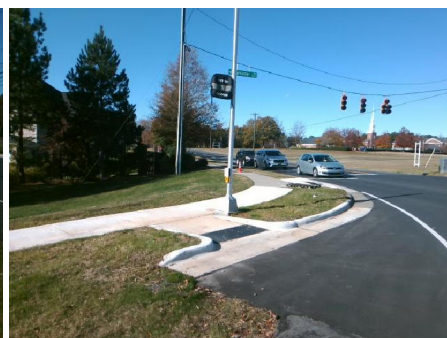
**Not Found, R304.2.1, R304.2.2-Perp, R304.3.2-Para**

| Compliance | Description | Data | Compliance | Description | Data |
|---|---|---|---|---|---|
| No | Landing Length (in) | 45.5 | Yes | DWS Provided? | Yes |
| No | Landing Slope (%) | 2.9 | Yes | DWS Length (in) | 24.0 |

**Remove & Replace Entire Ramp.**
