Access Compliance Report

Public Rights-of-Way

(Curb Ramps)

Intersection ID: 13118	Main Street: E_7TH_ST	Cross Street: CENTRAL_AV	Location: N
ADA ID: 0DB6A45AE625	Ramp Type: PerpDiag	Initial Pass/Fail: Fail	Overall Compliance: No
			Severity Score: 33.75

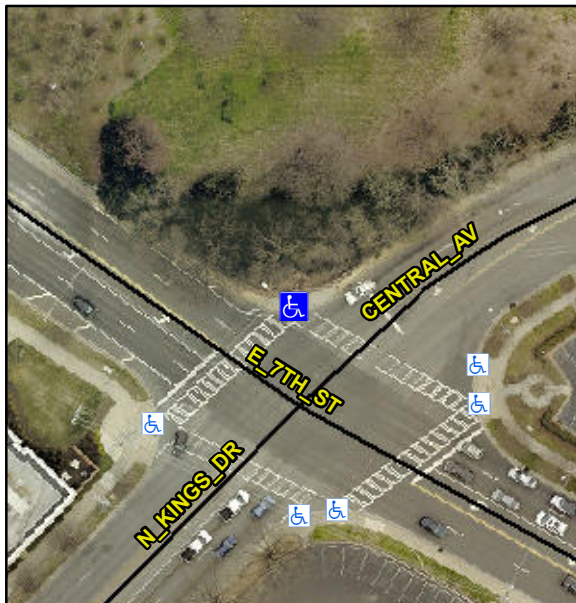
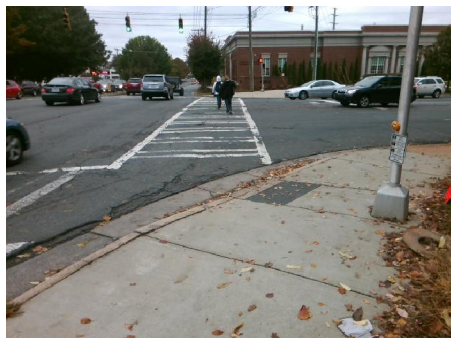
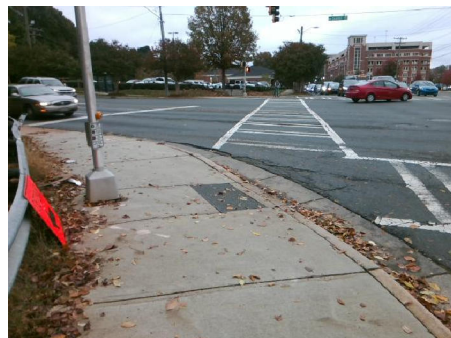
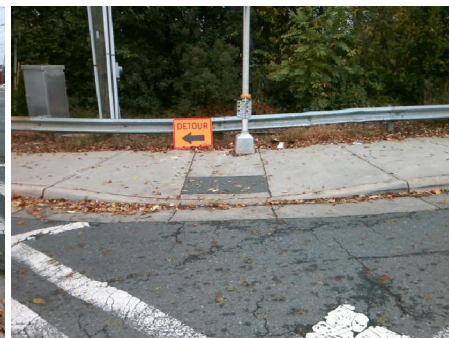
Not Found, R304.5.1, R304.2.2, R304.5.3

Compliance	Description	Data	Compliance	Description	Data
N/A	Ramp Length (in)	64.0	No	Ramp Slope (%)	8.7
No	Ramp Width (in)	47.0	No	Ramp XSlope (%)	5.6
N/A	Flare Type LT	N/A	N/A	Flare Type RT	N/A
N/A	Flare Slope LT (%)	N/A	N/A	Flare Slope RT (%)	N/A
N/A	Flare Traversable LT?	N/A	N/A	Flare Traversable RT?	N/A
N/A	Landing Length (in)	N/A	N/A	DWS Provided?	N/A
N/A	Landing Width (in)	N/A	N/A	DWS Contrast?	N/A
N/A	Landing Slope (%)	N/A	N/A	DWS Length (in)	N/A
N/A	Landing X Slope (%)	N/A	N/A	DWS Full Width?	N/A
N/A	Landing Curb? (Y/N)	N/A	N/A	DWS Offset (in)	N/A
N/A	Shared Landing?	N/A			
N/A	Gutter Ponding?	Yes	N/A	Gutter Slope (%)	N/A
N/A	Gutter Lip Ht (in)	N/A	N/A	Gutter X Slope (%)	N/A
N/A	Painted X Walk1?	Yes	N/A	Painted X Walk2?	Yes
	X Walk 1 Direction	To SW		X Walk 2 Direction	To SE
N/A	X Walk 1 Width (in)	110.0	N/A	X Walk 2 Width (in)	110.0
	X Walk 1 Slope (%)	0.0		X Walk 2 Slope (%)	5.6
	X Walk 1 X Slope (%)	5.2		X Walk 2 X Slope (%)	0.7

N/A	Ramp inside XWalk1?	Yes	N/A	Ramp inside XWalk2?	Yes
	Road Slope (%)	6.5	N/A	Clear Space?	N/A
	Road X Slope (%)	0.2	N/A	Clear Space to XWalk (in)	N/A
N/A	Any Obstructions?	N/A	N/A	Storm Grate/Utility Hazard?	N/A
	Obstruction Type			Storm Grate/Utility Type	
		N/A			N/A
		Yes		Surface Condition? (G/P)	Good

Remove & Replace Curb Ramp With Two New Directional Ramps or Equivalent.
