Access Compliance Report

Public Rights-of-Way

(Curb Ramps)

Intersection ID: 31746	Main Street: WASHOE_PINE_LN	Cross Street: PAPER_BIRCH_DR	Location: NW
ADA ID: 0DB8020D4439	Ramp Type: Perp	Initial Pass/Fail: Fail	Overall Compliance: No
		Severity Score: 10

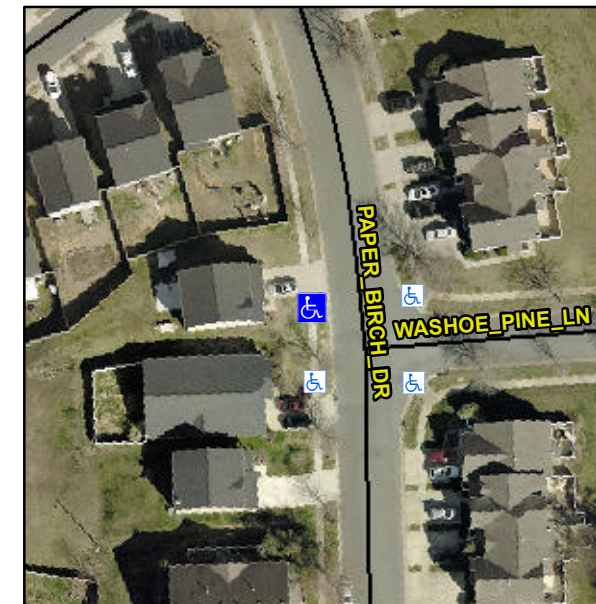
Not Found, R304.5.1, R304.5.3

Compliance	Description	Data	Compliance	Description	Data
N/A	Ramp Length (in)	81.5	Yes	Ramp Slope (%)	6.5
No	Ramp Width (in)	47.5	No	Ramp XSlope (%)	2.1
N/A	Flare Type LT	N/A	N/A	Flare Type RT	N/A
N/A	Flare Slope LT (%)	N/A	N/A	Flare Slope RT (%)	N/A
N/A	Flare Traversable LT?	N/A	N/A	Flare Traversable RT?	N/A
N/A	Landing Length (in)	N/A	N/A	DWS Provided?	N/A
N/A	Landing Width (in)	N/A	N/A	DWS Contrast?	N/A
N/A	Landing Slope (%)	N/A	N/A	DWS Length (in)	N/A
N/A	Landing X Slope (%)	N/A	N/A	DWS Full Width?	N/A
N/A	Landing Curb? (Y/N)	N/A	N/A	DWS Offset (in)	N/A
N/A	Shared Landing?	N/A			
N/A	Gutter Ponding?	N/A	N/A	Gutter Slope (%)	N/A
N/A	Gutter Lip Ht (in)	N/A	N/A	Gutter X Slope (%)	N/A
N/A	Painted X Walk1?	No	N/A	Painted X Walk2?	N/A
	X Walk 1 Direction	To E		X Walk 2 Direction	N/A
N/A	X Walk 1 Width (in)	N/A	N/A	X Walk 2 Width (in)	N/A
	X Walk 1 Slope (%)	2.4		X Walk 2 Slope (%)	N/A
	X Walk 1 X Slope (%)	1.7		X Walk 2 X Slope (%)	N/A

N/A	Ramp inside XWalk1?	N/A	N/A	Ramp inside XWalk2?	N/A
	Road Slope (%)	N/A	N/A	Clear Space?	N/A
	Road X Slope (%)	N/A	N/A	Clear Space to XWalk (in)	N/A
N/A	Any Obstructions?	N/A	N/A	Storm Grate/Utility Hazard?	N/A
	Obstruction Type			Storm Grate/Utility Type	
		N/A			N/A
			Yes	Surface Condition? (G/P)	Good

Remove & Replace Entire Ramp.
