Access Compliance Report

Public Rights-of-Way

(Curb Ramps)

Intersection ID: 54465	Main Street: RUPELL_DR	Cross Street: COLLINGHAM_DR	Location: SE
ADA ID: 0DBBFF5A6BE9	Ramp Type: BlendTrans1	Initial Pass/Fail: Fail	Overall Compliance: No
		Severity Score: 10

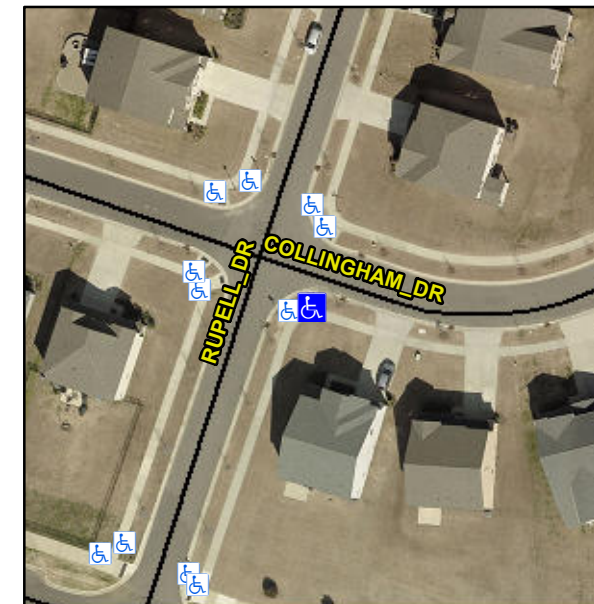
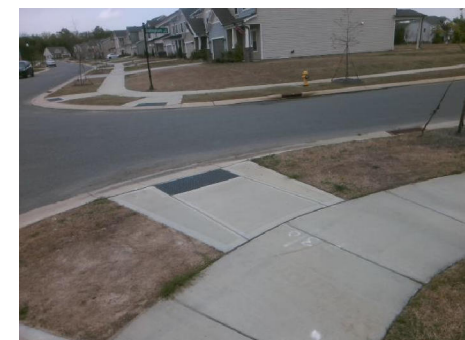
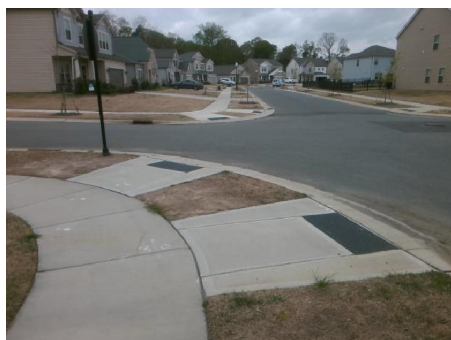
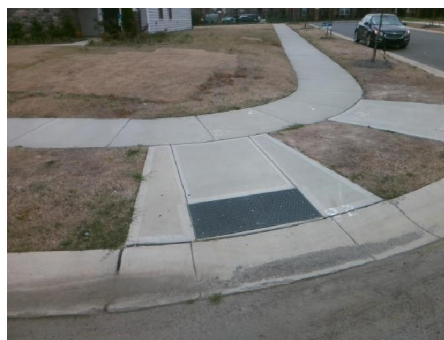
Not Found, R304.5.1, R304.5.3

Compliance	Description	Data	Compliance	Description	Data
N/A	Ramp Length (in)	95.0	Yes	BlendTrans Slope (%)	4.3
No	Ramp Width (in)	46.0	No	BlendTrans XSlope (%)	2.2
N/A	Flare Type LT	N/A	N/A	Flare Type RT	N/A
N/A	Flare Slope LT (%)	N/A	N/A	Flare Slope RT (%)	N/A
N/A	Flare Traversable LT?	N/A	N/A	Flare Traversable RT?	N/A
N/A	Landing Length (in)	N/A	N/A	DWS Provided?	N/A
N/A	Landing Width (in)	N/A	N/A	DWS Contrast?	N/A
N/A	Landing Slope (%)	N/A	N/A	DWS Length (in)	N/A
N/A	Landing X Slope (%)	N/A	N/A	DWS Full Width?	N/A
N/A	Landing Curb? (Y/N)	N/A	N/A	DWS Offset (in)	N/A
N/A	Shared Landing?	N/A			
N/A	Gutter Ponding?	N/A	N/A	Gutter Slope (%)	N/A
N/A	Gutter Lip Ht (in)	N/A	N/A	Gutter X Slope (%)	N/A
N/A	Painted X Walk1?	No	N/A	Painted X Walk2?	N/A
	X Walk 1 Direction	To NE		X Walk 2 Direction	N/A
	X Walk 1 Width (in)	N/A		X Walk 2 Width (in)	N/A
	X Walk 1 Slope (%)	2.5		X Walk 2 Slope (%)	N/A
	X Walk 1 X Slope (%)	0.5		X Walk 2 X Slope (%)	N/A

N/A	Ramp inside XWalk1?	N/A	N/A	Ramp inside XWalk2?	N/A
	Road Slope (%)	0.5		Clear Space?	N/A
	Road X Slope (%)	2.5	N/A	Clear Space to XWalk (in)	N/A
N/A	Any Obstructions?	N/A	N/A	Storm Grate/Utility Hazard?	N/A
	Obstruction Type			Storm Grate/Utility Type	
		N/A			N/A
			Yes	Surface Condition? (G/P)	Good
			No	Curb Slope (%)	8.8

Remove & Replace Curb Ramp With Two New Directional Ramps or Equivalent.

Total Cost: \$ 3200.00
