Access Compliance Report

Public Rights-of-Way

(Curb Ramps)

Intersection ID: 54260	Main Street: BALLANTYNE_COMMONS_PY	Cross Street: BLACK_FOREST_LN	Location:	N
ADA ID: 0DC132314938	Ramp Type: Perp	Initial Pass/Fail: Fail	Overall Compliance: No	Severity Score: 10
Codes/Mitigation Info/Possible Solution		Field Measurements/Component Compliance

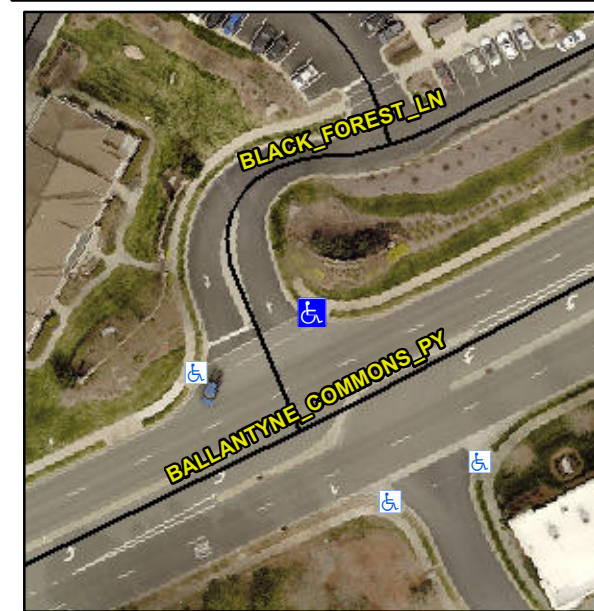
Not Found, R304.5.1, R304.5.3

Compliance	Description	Data	Compliance	Description	Data
N/A	Ramp Length (in)	108.5	Yes	Ramp Slope (%)	7.2
No	Ramp Width (in)	36.0	No	Ramp XSlope (%)	3.3
N/A	Flare Type LT	N/A	N/A	Flare Type RT	N/A
N/A	Flare Slope LT (%)	N/A	N/A	Flare Slope RT (%)	N/A
N/A	Flare Traversable LT?	N/A	N/A	Flare Traversable RT?	N/A
N/A	Landing Length (in)	N/A	N/A	DWS Provided?	N/A
N/A	Landing Width (in)	N/A	N/A	DWS Contrast?	N/A
N/A	Landing Slope (%)	N/A	N/A	DWS Length (in)	N/A
N/A	Landing X Slope (%)	N/A	N/A	DWS Full Width?	N/A
N/A	Landing Curb? (Y/N)	N/A	N/A	DWS Offset (in)	N/A
N/A	Shared Landing?	N/A			
N/A	Gutter Ponding?	N/A	N/A	Gutter Slope (%)	N/A
N/A	Gutter Lip Ht (in)	N/A	N/A	Gutter X Slope (%)	N/A
N/A	Painted X Walk1?	Yes	N/A	Painted X Walk2?	N/A
	X Walk 1 Direction	To W		X Walk 2 Direction	N/A
N/A	X Walk 1 Width (in)	102.5	N/A	X Walk 2 Width (in)	N/A
	X Walk 1 Slope (%)	1.6		X Walk 2 Slope (%)	N/A
	X Walk 1 X Slope (%)	3.7		X Walk 2 X Slope (%)	N/A

N/A	Ramp inside XWalk1?	Yes	N/A	Ramp inside XWalk2?	N/A
	Road Slope (%)	N/A	N/A	Clear Space?	N/A
	Road X Slope (%)	N/A	N/A	Clear Space to XWalk (in)	N/A
N/A	Any Obstructions?	N/A	N/A	Storm Grate/Utility Hazard?	N/A
	Obstruction Type			Storm Grate/Utility Type	
		N/A			N/A
			Yes	Surface Condition? (G/P)	Good

Remove & Replace Entire Ramp.

Total Cost: \$ 1850.00
