# Access Compliance Report

## Public Rights-of-Way

### (Curb Ramps)

Intersection ID: 10026441	Main Street: FARMHURST_DR	Cross Street: N/A	Location: SW
ADA ID: 0DD76BE7B56B	Ramp Type: PerpDiag	Initial Pass/Fail: Fail	Overall Compliance: No
		Severity Score: 25

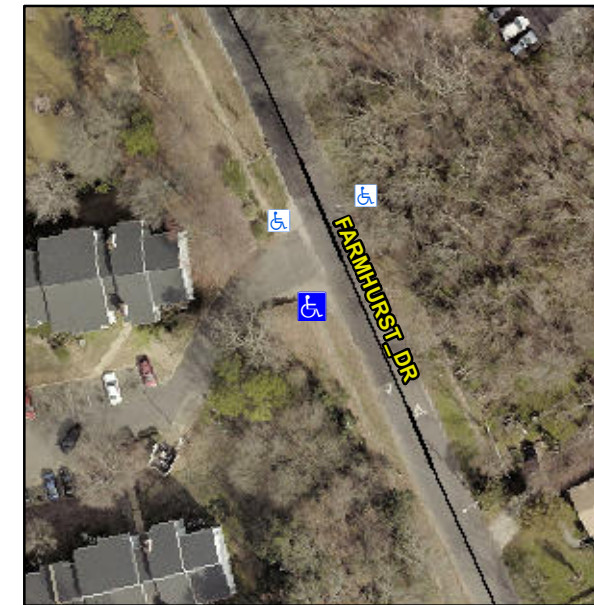
**Not Found, R304.2.2, R304.5.3**

Compliance	Description	Data	Compliance	Description	Data
N/A	Ramp Length (in)	38.0	No	Ramp Slope (%)	8.8
Yes	Ramp Width (in)	48.0	No	Ramp XSlope (%)	5.8
N/A	Flare Type LT	N/A	N/A	Flare Type RT	N/A
N/A	Flare Slope LT (%)	N/A	N/A	Flare Slope RT (%)	N/A
N/A	Flare Traversable LT?	N/A	N/A	Flare Traversable RT?	N/A
N/A	Landing Length (in)	N/A	N/A	DWS Provided?	N/A
N/A	Landing Width (in)	N/A	N/A	DWS Contrast?	N/A
N/A	Landing Slope (%)	N/A	N/A	DWS Length (in)	N/A
N/A	Landing X Slope (%)	N/A	N/A	DWS Full Width?	N/A
N/A	Landing Curb? (Y/N)	N/A	N/A	DWS Offset (in)	N/A
N/A	Shared Landing?	N/A			
N/A	Gutter Ponding?	N/A	N/A	Gutter Slope (%)	N/A
N/A	Gutter Lip Ht (in)	N/A	N/A	Gutter X Slope (%)	N/A
N/A	Painted X Walk1?	No	N/A	Painted X Walk2?	No
	X Walk 1 Direction	To E		X Walk 2 Direction	To N
N/A	X Walk 1 Width (in)	N/A	N/A	X Walk 2 Width (in)	N/A
	X Walk 1 Slope (%)	10.9		X Walk 2 Slope (%)	0.8
	X Walk 1 X Slope (%)	3.5		X Walk 2 X Slope (%)	7.1

N/A	Ramp inside XWalk1?	N/A	N/A	Ramp inside XWalk2?	N/A
	Road Slope (%)	9.5	N/A	Clear Space?	N/A
	Road X Slope (%)	2.7	N/A	Clear Space to XWalk (in)	N/A
N/A	Any Obstructions?	N/A	N/A	Storm Grate/Utility Hazard?	N/A
	Obstruction Type			Storm Grate/Utility Type	
		N/A			N/A
		Yes		Surface Condition? (G/P)	Good

**Remove & Replace Curb Ramp With Two New Directional Ramps or Equivalent.**

Total Cost: \$ 3200.00
