# Access Compliance Report

## Public Rights-of-Way

### (Curb Ramps)

Intersection ID: N/A	Main Street: S_BREVARD_ST	Cross Street: N/A	Location: E
ADA ID: 0DEA700B071C	Ramp Type: BlendTrans1	Initial Pass/Fail: Pass	Overall Compliance: No
Severity Score: 0.25			
Codes/Mitigation Info/Possible Solution		Field Measurements/Component Compliance

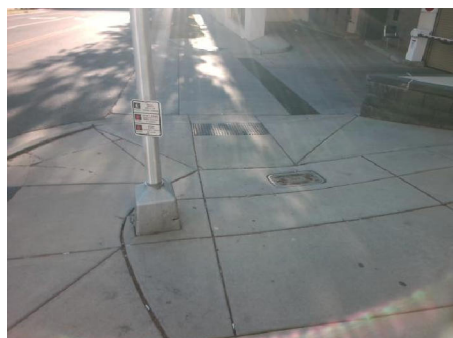
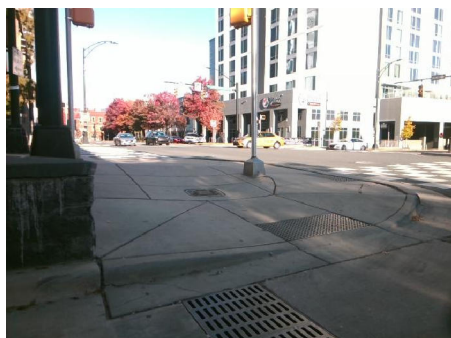
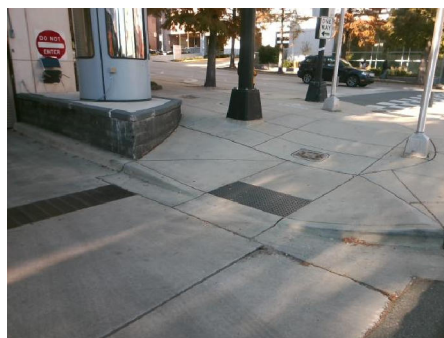
**Not Found, R304.5.3, R304.2.2-Perp, R304.3.2-Para**

Compliance	Description	Data	Compliance	Description	Data
N/A	Ramp Length (in)	76.0	Yes	BlendTrans Slope (%)	4.0
Yes	Ramp Width (in)	48.0	No	BlendTrans XSlope (%)	2.4
N/A	Flare Type LT	Sloped	N/A	Flare Type RT	Sloped
N/A	Flare Slope LT (%)	6.5	N/A	Flare Slope RT (%)	15.2
N/A	Flare Traversable LT?	No	N/A	Flare Traversable RT?	No
Yes	Landing Length (in)	101.5	Yes	DWS Provided?	Yes
Yes	Landing Width (in)	48.0	Yes	DWS Contrast?	Yes
No	Landing Slope (%)	12.7	Yes	DWS Length (in)	25.0
No	Landing X Slope (%)	3.2	Yes	DWS Full Width?	Yes
N/A	Landing Curb? (Y/N)	No	Yes	DWS Offset (in)	0.0
N/A	Shared Landing?	No			
Yes	Gutter Ponding?	No	Yes	Gutter Slope (%)	0.4
Yes	Gutter Lip Ht (in)	0.0	No	Gutter X Slope (%)	2.2
N/A	Painted X Walk1?	No	N/A	Painted X Walk2?	N/A
	X Walk 1 Direction	To W		X Walk 2 Direction	N/A
	X Walk 1 Width (in)	N/A		X Walk 2 Width (in)	N/A
	X Walk 1 Slope (%)	1.3		X Walk 2 Slope (%)	N/A
	X Walk 1 X Slope (%)	2.0		X Walk 2 X Slope (%)	N/A

N/A	Ramp inside XWalk1?	N/A	N/A	Ramp inside XWalk2?	N/A
	Road Slope (%)	2.0		Clear Space?	Yes
	Road X Slope (%)	1.3	N/A	Clear Space to XWalk (in)	N/A
Yes	Any Obstructions?	No	Yes	Storm Grate/Utility Hazard?	No
	Obstruction Type			Storm Grate/Utility Type	
		N/A			N/A
			Yes	Surface Condition? (G/P)	Good
			No	Curb Slope (%)	13.9

**Remove & Replace Curb Ramp With Two New Directional Ramps or Equivalent. Remove & Replace Gutter.**
