Access Compliance Report

Public Rights-of-Way

(Curb Ramps)

Intersection ID: 48058	Main Street: FERRELL_AV	Cross Street: KEENER_RIDGE_RD	Location: NE
ADA ID: 0DEA72F11C2D	Ramp Type: Perp	Initial Pass/Fail: Fail	Overall Compliance: No
Severity Score: 10			
Codes/Mitigation Info/Possible Solution		Field Measurements/Component Compliance

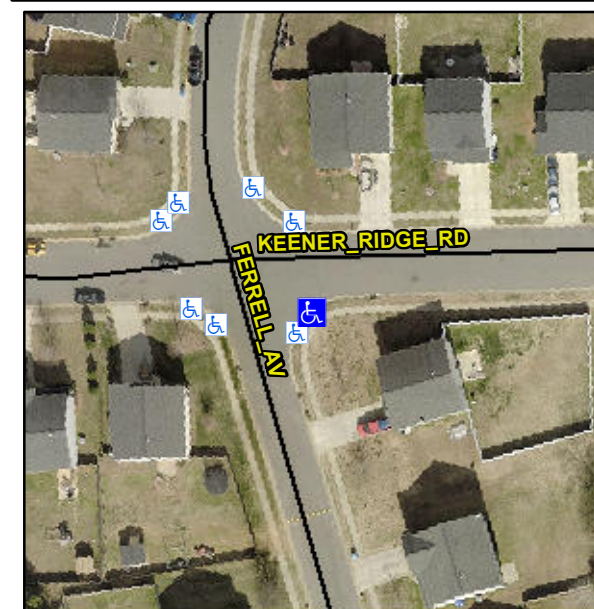
Not Found, R304.5.1, R304.5.3

Compliance	Description	Data	Compliance	Description	Data
N/A	Ramp Length (in)	47.0	Yes	Ramp Slope (%)	7.1
No	Ramp Width (in)	46.5	No	Ramp XSlope (%)	4.4
N/A	Flare Type LT	N/A	N/A	Flare Type RT	N/A
N/A	Flare Slope LT (%)	N/A	N/A	Flare Slope RT (%)	N/A
N/A	Flare Traversable LT?	N/A	N/A	Flare Traversable RT?	N/A
N/A	Landing Length (in)	N/A	N/A	DWS Provided?	N/A
N/A	Landing Width (in)	N/A	N/A	DWS Contrast?	N/A
N/A	Landing Slope (%)	N/A	N/A	DWS Length (in)	N/A
N/A	Landing X Slope (%)	N/A	N/A	DWS Full Width?	N/A
N/A	Landing Curb? (Y/N)	N/A	N/A	DWS Offset (in)	N/A
N/A	Shared Landing?	N/A			
N/A	Gutter Ponding?	N/A	N/A	Gutter Slope (%)	N/A
N/A	Gutter Lip Ht (in)	N/A	N/A	Gutter X Slope (%)	N/A
N/A	Painted X Walk1?	No	N/A	Painted X Walk2?	N/A
	X Walk 1 Direction	To N		X Walk 2 Direction	N/A
N/A	X Walk 1 Width (in)	N/A	N/A	X Walk 2 Width (in)	N/A
	X Walk 1 Slope (%)	1.0		X Walk 2 Slope (%)	N/A
	X Walk 1 X Slope (%)	4.8		X Walk 2 X Slope (%)	N/A

N/A	Ramp inside XWalk1?	N/A	N/A	Ramp inside XWalk2?	N/A
	Road Slope (%)	N/A	N/A	Clear Space?	N/A
	Road X Slope (%)	N/A	N/A	Clear Space to XWalk (in)	N/A
N/A	Any Obstructions?	N/A	N/A	Storm Grate/Utility Hazard?	N/A
	Obstruction Type			Storm Grate/Utility Type	
		N/A			N/A
			Yes	Surface Condition? (G/P)	Good

Remove & Replace Entire Ramp.
