## Access Compliance Report Public Rights-of-Way (Curb Ramps)

Intersection ID: 14061 Main Street: BARCLIFF\_DR Cross Street: LAWRENCE\_ORR\_RD Location: SW

ADA ID: 0DF3690F8930 Ramp Type: BlendTrans1 Initial Pass/Fail: Fail Overall Compliance: No Severity Score: 8.75

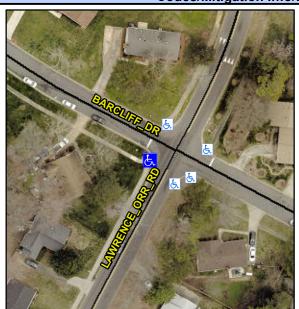
Field Measurements/Component Compliance					
Compliance Description		Data	Compliance Description		Data
N/A	Ramp Length (in)	47.5	Yes	BlendTrans Slope (%)	3.7
No	Ramp Width (in)	46.5	Yes	BlendTrans XSlope (%)	0.3
N/A	Flare Type LT	N/A	N/A	Flare Type RT	N/A
N/A	Flare Slope LT (%)	N/A	N/A	Flare Slope RT (%)	N/A
N/A	Flare Traversable LT?	N/A	N/A	Flare Traversable RT?	N/A
N/A	Landing Length (in)	N/A	N/A	DWS Provided?	N/A
N/A	Landing Width (in)	N/A	N/A	DWS Contrast?	N/A
N/A	Landing Slope (%)	N/A	N/A	DWS Length (in)	N/A
N/A	Landing X Slope (%)	N/A	N/A	DWS Full Width?	N/A
N/A	Landing Curb? (Y/N)	N/A	N/A	DWS Offset (in)	N/A
N/A	Shared Landing?	N/A			
N/A	Gutter Ponding?	N/A	N/A	Gutter Slope (%)	N/A
N/A	Gutter Lip Ht (in)	N/A	N/A	Gutter X Slope (%)	N/A
N/A	Painted X Walk1?	No	N/A	Painted X Walk2?	No
	X Walk 1 Direction	To SE		X Walk 2 Direction	To NE
	X Walk 1 Width (in)	N/A		X Walk 2 Width (in)	N/A
	X Walk 1 Slope (%)	3.7		X Walk 2 Slope (%)	2.5

X Walk 1 X Slope (%)	0.7		X Walk 2 X Slope (%)	1.3
N/A	Ramp inside XWalk1?	N/A	N/A	Ramp inside XWalk2?	N/A
	Road Slope (%)	4.9		Clear Space?	N/A
	Road X Slope (%)	2.7	N/A	Clear Space to XWalk (in)	N/A
N/A	Any Obstructions?	N/A	N/A	Storm Grate/Utility Hazard?	N/A
	Obstruction Type		l	Storm Grate/Utility Type	
		N/A	l		N/A
			Yes	Surface Condition? (G/P)	Good

No

Curb Slope (%)

12.7

Remove & Replace Curb Ramp With
Two New Directional Ramps or
Equivalent.

PROW/ADA:
Not Found, R304.5.1
