# Access Compliance Report

## Public Rights-of-Way

### (Curb Ramps)

Intersection ID: 9283	Main Street: FERNDALE_PL	Cross Street: THE_PLAZA	Location:	N
ADA ID: 0DFD5CF91F2D	Ramp Type: Perp	Initial Pass/Fail: Fail	Overall Compliance: No	Severity Score: 10
Codes/Mitigation Info/Possible Solution		Field Measurements/Component Compliance

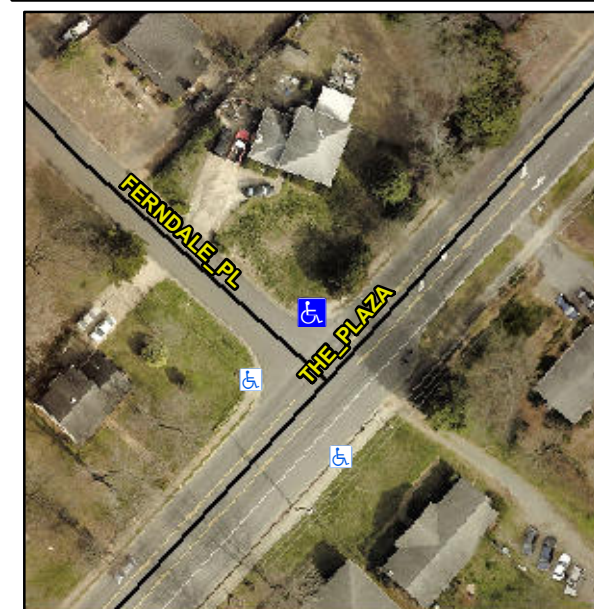
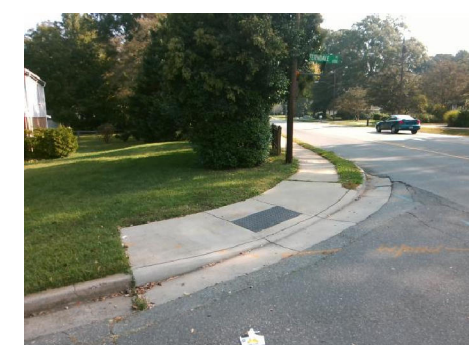
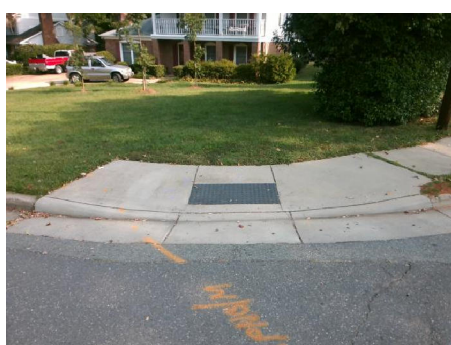
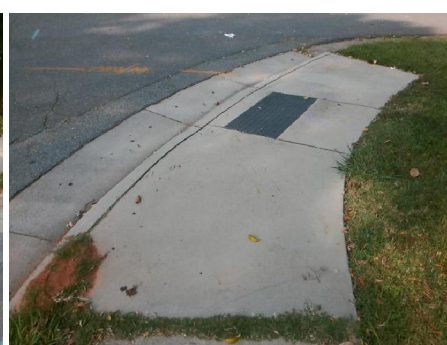
**Not Found, R304.5.1, R304.5.3**

Compliance	Description	Data	Compliance	Description	Data
N/A	Ramp Length (in)	60.5	Yes	Ramp Slope (%)	7.6
No	Ramp Width (in)	47.0	No	Ramp XSlope (%)	2.4
N/A	Flare Type LT	N/A	N/A	Flare Type RT	N/A
N/A	Flare Slope LT (%)	N/A	N/A	Flare Slope RT (%)	N/A
N/A	Flare Traversable LT?	N/A	N/A	Flare Traversable RT?	N/A
N/A	Landing Length (in)	N/A	N/A	DWS Provided?	N/A
N/A	Landing Width (in)	N/A	N/A	DWS Contrast?	N/A
N/A	Landing Slope (%)	N/A	N/A	DWS Length (in)	N/A
N/A	Landing X Slope (%)	N/A	N/A	DWS Full Width?	N/A
N/A	Landing Curb? (Y/N)	N/A	N/A	DWS Offset (in)	N/A
N/A	Shared Landing?	N/A			
N/A	Gutter Ponding?	N/A	N/A	Gutter Slope (%)	N/A
N/A	Gutter Lip Ht (in)	0.5	N/A	Gutter X Slope (%)	N/A
N/A	Painted X Walk1?	No	N/A	Painted X Walk2?	N/A
	X Walk 1 Direction	To SW		X Walk 2 Direction	N/A
N/A	X Walk 1 Width (in)	N/A	N/A	X Walk 2 Width (in)	N/A
	X Walk 1 Slope (%)	1.2		X Walk 2 Slope (%)	N/A
	X Walk 1 X Slope (%)	3.7		X Walk 2 X Slope (%)	N/A

N/A	Ramp inside XWalk1?	N/A	N/A	Ramp inside XWalk2?	N/A
	Road Slope (%)	N/A	N/A	Clear Space?	N/A
	Road X Slope (%)	N/A	N/A	Clear Space to XWalk (in)	N/A
N/A	Any Obstructions?	N/A	N/A	Storm Grate/Utility Hazard?	N/A
	Obstruction Type			Storm Grate/Utility Type	
		N/A			N/A
			Yes	Surface Condition? (G/P)	Good

**Remove & Replace Entire Ramp.**

Total Cost: \$ 1850.00
