Access Compliance Report

Public Rights-of-Way

(Curb Ramps)

Intersection ID: 43601	Main Street: BALLANTYNE COMMONS PY	Cross Street: COSTIGAN LN	Location:	SW
ADA ID: 0DFE3E5E0B3A	Ramp Type: BlendTrans1	Initial Pass/Fail: Fail	Overall Compliance: No	Severity Score: 10

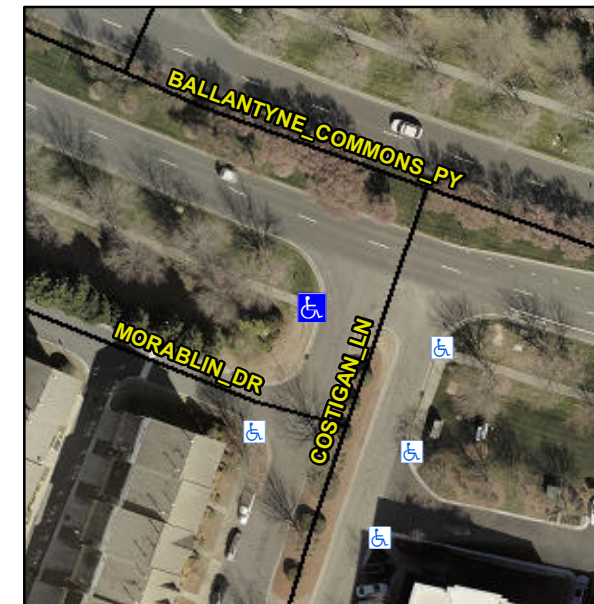
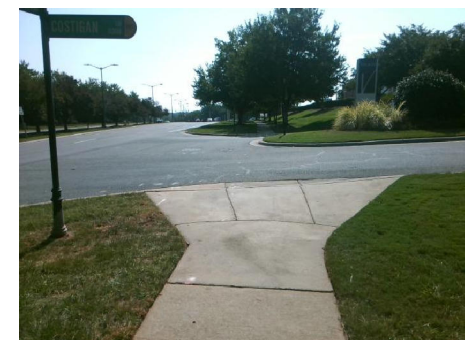
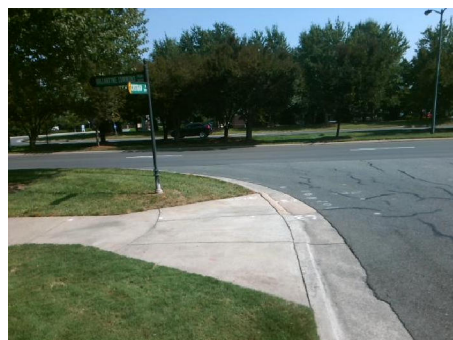
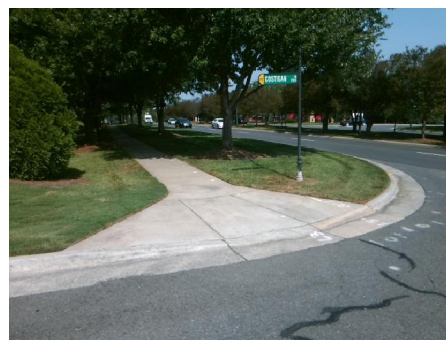
Not Found, R304.5.1, R304.5.3

Compliance	Description	Data	Compliance	Description	Data
N/A	Ramp Length (in)	91.0	Yes	BlendTrans Slope (%)	0.6
No	Ramp Width (in)	44.0	No	BlendTrans XSlope (%)	3.2
N/A	Flare Type LT	N/A	N/A	Flare Type RT	N/A
N/A	Flare Slope LT (%)	N/A	N/A	Flare Slope RT (%)	N/A
N/A	Flare Traversable LT?	N/A	N/A	Flare Traversable RT?	N/A
N/A	Landing Length (in)	N/A	N/A	DWS Provided?	N/A
N/A	Landing Width (in)	N/A	N/A	DWS Contrast?	N/A
N/A	Landing Slope (%)	N/A	N/A	DWS Length (in)	N/A
N/A	Landing X Slope (%)	N/A	N/A	DWS Full Width?	N/A
N/A	Landing Curb? (Y/N)	N/A	N/A	DWS Offset (in)	N/A
N/A	Shared Landing?	N/A			
N/A	Gutter Ponding?	N/A	N/A	Gutter Slope (%)	N/A
N/A	Gutter Lip Ht (in)	N/A	N/A	Gutter X Slope (%)	N/A
N/A	Painted X Walk1?	No	N/A	Painted X Walk2?	N/A
	X Walk 1 Direction	To SE		X Walk 2 Direction	N/A
	X Walk 1 Width (in)	N/A		X Walk 2 Width (in)	N/A
	X Walk 1 Slope (%)	4.2		X Walk 2 Slope (%)	N/A
	X Walk 1 X Slope (%)	4.0		X Walk 2 X Slope (%)	N/A

N/A	Ramp inside XWalk1?	N/A	N/A	Ramp inside XWalk2?	N/A
	Road Slope (%)	4.0		Clear Space?	N/A
	Road X Slope (%)	4.2	N/A	Clear Space to XWalk (in)	N/A
N/A	Any Obstructions?	N/A	N/A	Storm Grate/Utility Hazard?	N/A
	Obstruction Type			Storm Grate/Utility Type	
		N/A			N/A
			Yes	Surface Condition? (G/P)	Good
			No	Curb Slope (%)	12.4

Remove & Replace Curb Ramp With Two New Directional Ramps or Equivalent.
