# Access Compliance Report

## Public Rights-of-Way

| Intersection ID: 28109 | Main Street: BLAKENEY_HEATH_RD | Cross Street: BORCHETTA_DR | Location: NE |
| ADA ID: 0DFFFB863B4 | Ramp Type: PerpDiag | Initial Pass/Fail: Pass | Overall Compliance: No |

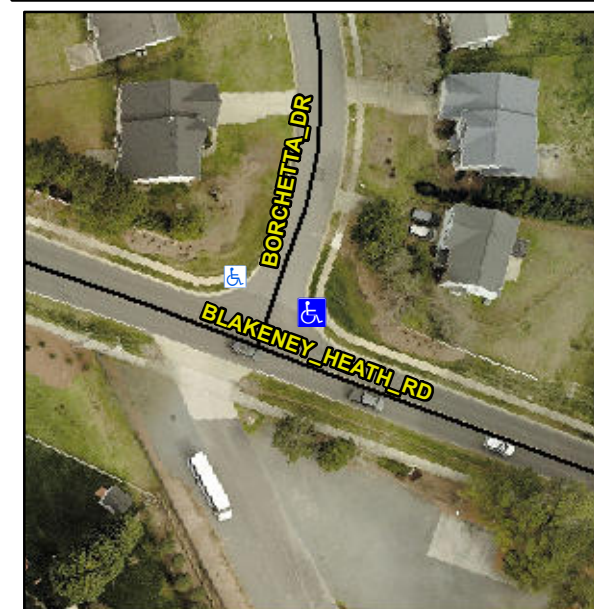
| Severity Score: 17.75 | | | |

**R304.5.3, R304.2.1, R304.2.2-Perp, R304.3.2-Para, R304.2.3, R304.5.4**

| Compliance | Description | Data | Compliance | Description | Data |
|---|---|---|---|---|---|
| Yes | Ramp Width (in) | 48.0 | No | Ramp XSlope (%) | 2.8 |
| N/A | Flare Slope LT (%) | 2.9 | No | Flare Slope RT (%) | 11.3 |
| No | Landing Length (in) | N/A | Yes | DWS Provided? | Yes |
| No | Landing Width (in) | N/A | Yes | DWS Contrast? | Yes |
| No | Landing Slope (%) | N/A | Yes | DWS Length (in) | 24.0 |
| No | Landing X Slope (%) | N/A | Yes | DWS Full Width? | Yes |
| Yes | Gutter Ponding? | No | No | Gutter Slope (%) | 6.0 |
| Yes | Gutter Lip Ht (in) | 0.0 | No | Gutter X Slope (%) | 3.2 |

**Remove & Replace Curb Ramp With Two New Directional Ramps or Equivalent. Remove & Replace Gutter.**

Total Cost: \$ 3950.00

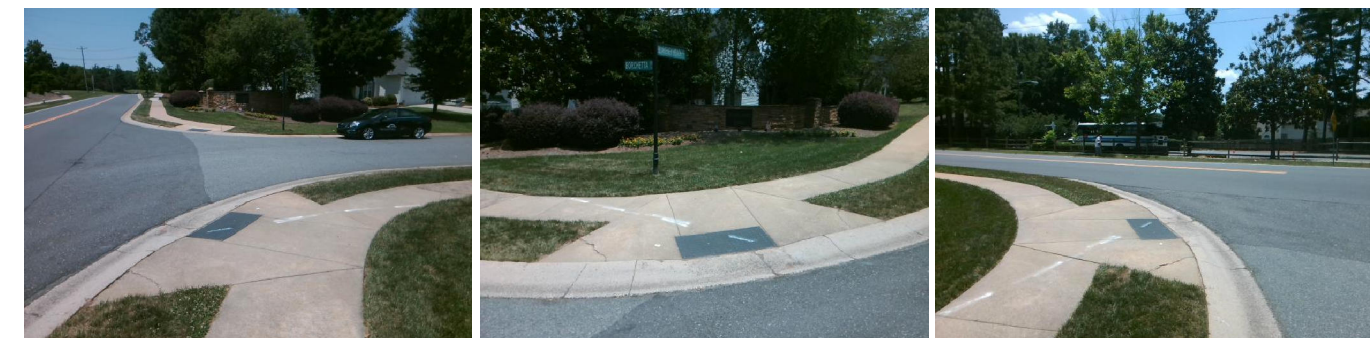
Street 1 Name **BORCHETTA DR**  
 Stop Condition-Street 2 **StopSign**  
 Street 2 Name **BLAKENEY HEATH RD**  
 Stop Condition-Street 1 **None**
