# Access Compliance Report

## Public Rights-of-Way

### (Curb Ramps)

Intersection ID: 9317	Main Street: JUDSON_AV	Cross Street: W_TRADE_ST	Location: W
ADA ID: 0E06AB826F62	Ramp Type: Perp	Initial Pass/Fail: Fail	Overall Compliance: No
Severity Score: 8.75			
Codes/Mitigation Info/Possible Solution		Field Measurements/Component Compliance

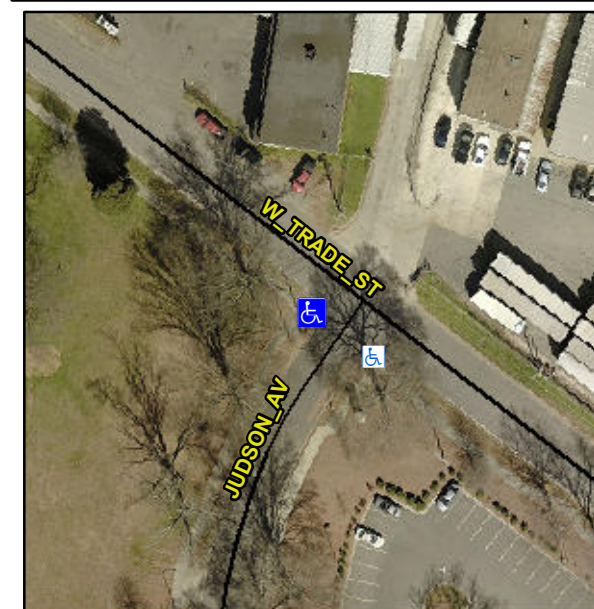
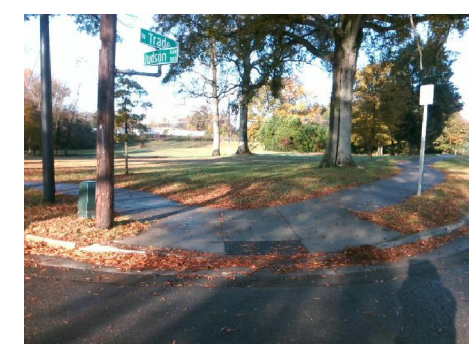
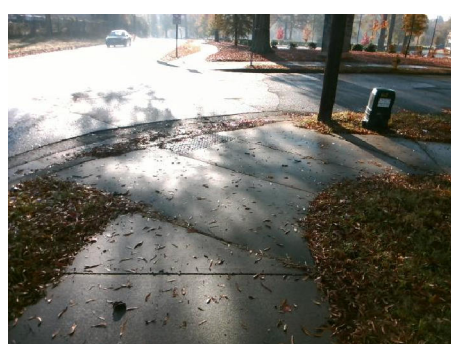
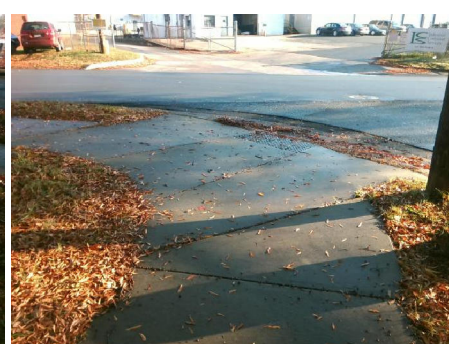
Compliance	Description	Data	Compliance	Description	Data
N/A	Ramp Length (in)	116.0	Yes	Ramp Slope (%)	5.0
No	Ramp Width (in)	47.5	Yes	Ramp XSlope (%)	1.3
N/A	Flare Type LT	N/A	N/A	Flare Type RT	N/A
N/A	Flare Slope LT (%)	N/A	N/A	Flare Slope RT (%)	N/A
N/A	Flare Traversable LT?	N/A	N/A	Flare Traversable RT?	N/A
N/A	Landing Length (in)	N/A	N/A	DWS Provided?	N/A
N/A	Landing Width (in)	N/A	N/A	DWS Contrast?	N/A
N/A	Landing Slope (%)	N/A	N/A	DWS Length (in)	N/A
N/A	Landing X Slope (%)	N/A	N/A	DWS Full Width?	N/A
N/A	Landing Curb? (Y/N)	N/A	N/A	DWS Offset (in)	N/A
N/A	Shared Landing?	N/A			
N/A	Gutter Ponding?	N/A	N/A	Gutter Slope (%)	N/A
N/A	Gutter Lip Ht (in)	0.5	N/A	Gutter X Slope (%)	N/A
N/A	Painted X Walk1?	No	N/A	Painted X Walk2?	N/A
	X Walk 1 Direction	To SE		X Walk 2 Direction	N/A
N/A	X Walk 1 Width (in)	N/A	N/A	X Walk 2 Width (in)	N/A
	X Walk 1 Slope (%)	0.7		X Walk 2 Slope (%)	N/A
	X Walk 1 X Slope (%)	2.8		X Walk 2 X Slope (%)	N/A

N/A	Ramp inside XWalk1?	N/A	N/A	Ramp inside XWalk2?	N/A
	Road Slope (%)	N/A	N/A	Clear Space?	N/A
	Road X Slope (%)	N/A	N/A	Clear Space to XWalk (in)	N/A
N/A	Any Obstructions?	N/A	N/A	Storm Grate/Utility Hazard?	N/A
	Obstruction Type			Storm Grate/Utility Type	
		N/A			N/A
		Yes		Surface Condition? (G/P)	Good

Possible Solutions:

**Remove & Replace Entire Ramp.**

**R304.5.1**

**\$ 1850.00**
