# Access Compliance Report

## Public Rights-of-Way

| Intersection ID: 28364 | Main Street: HIGHLANDS_CROSSING_DR | Cross Street: SOUTHAMPTON_COMMONS_DR | Location: NW |
| ADA ID: 0E08C37131E0 | Ramp Type: PerpDiag | Initial Pass/Fail: Fail | Overall Compliance: No |

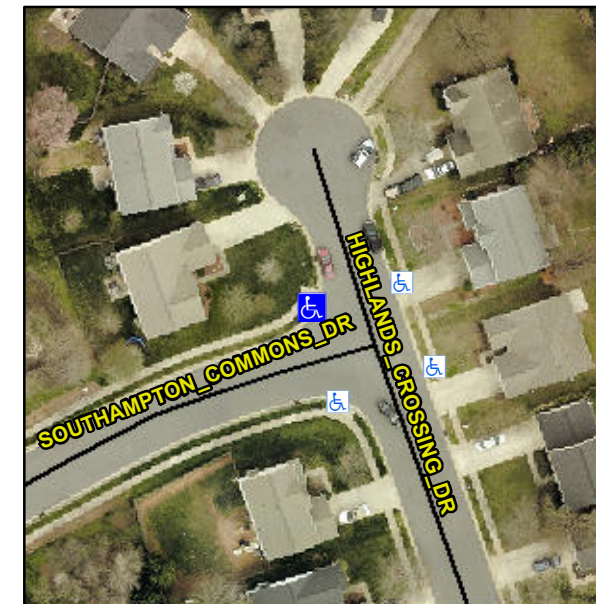
| Severity Score: 21.25 | | | |

**Not Found, R304.5.1, R304.5.3**

| Compliance | Description | Data | Compliance | Description | Data |
|---|---|---|---|---|---|
| N/A | Ramp Length (in) | 47.0 | Yes | Ramp Slope (%) | 8.2 |
| No | Ramp Width (in) | 38.0 | No | Ramp XSlope (%) | 5.3 |

**Remove & Replace Curb Ramp With Two New Directional Ramps or Equivalent.**

Total Cost: \$ 3200.00
