# Access Compliance Report

## Public Rights-of-Way

### (Curb Ramps)

Intersection ID: 11526	Main Street: W_8TH_ST	Cross Street: N_GRAHAM_ST	Location: N
ADA ID: 0E1680D7C909	Ramp Type: PerpDiag	Initial Pass/Fail: Pass	Overall Compliance: No
		Severity Score: 10

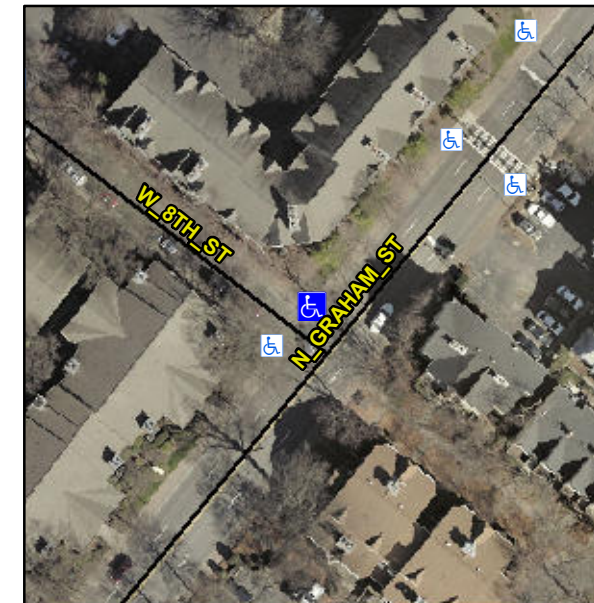
**Not Found, R304.2.1, R304.2.2-Perp, R304.3.2-Para, R304.5.3, R305.2**

Compliance	Description	Data	Compliance	Description	Data
N/A	Ramp Length (in)	45.0	Yes	Ramp Slope (%)	7.1
Yes	Ramp Width (in)	48.0	Yes	Ramp XSlope (%)	1.2
N/A	Flare Type LT	Sloped	N/A	Flare Type RT	N/A
N/A	Flare Slope LT (%)	5.5	Yes	Flare Slope RT (%)	5.1
N/A	Flare Traversable LT?	Yes	N/A	Flare Traversable RT?	Yes
No	Landing Length (in)	N/A	Yes	DWS Provided?	Yes
No	Landing Width (in)	N/A	Yes	DWS Contrast?	Yes
No	Landing Slope (%)	N/A	Yes	DWS Length (in)	24.0
No	Landing X Slope (%)	N/A	Yes	DWS Full Width?	Yes
N/A	Landing Curb? (Y/N)	No	No	DWS Offset (in)	5.0
N/A	Shared Landing?	No			
Yes	Gutter Ponding?	No	Yes	Gutter Slope (%)	0.8
Yes	Gutter Lip Ht (in)	0.0	Yes	Gutter X Slope (%)	0.7
N/A	Painted X Walk1?	No	N/A	Painted X Walk2?	No
	X Walk 1 Direction	To SW		X Walk 2 Direction	To SE
N/A	X Walk 1 Width (in)	N/A	N/A	X Walk 2 Width (in)	N/A
	X Walk 1 Slope (%)	1.8		X Walk 2 Slope (%)	3.6
	X Walk 1 X Slope (%)	1.1		X Walk 2 X Slope (%)	0.8

N/A	Ramp inside XWalk1?	N/A	N/A	Ramp inside XWalk2?	N/A
	Road Slope (%)	0.4	N/A	Clear Space?	No
	Road X Slope (%)	1.8	N/A	Clear Space to XWalk (in)	N/A
Yes	Any Obstructions?	No	Yes	Storm Grate/Utility Hazard?	No
	Obstruction Type			Storm Grate/Utility Type	
		N/A			N/A
			Yes	Surface Condition? (G/P)	Good

**Remove & Replace Curb Ramp With Two New Directional Ramps or Equivalent.**
