Access Compliance Report

Public Rights-of-Way

(Curb Ramps)

Intersection ID: 43998	Main Street: GANDER_DR	Cross Street: SUMMERBERRY_CT	Location: NE
ADA ID: 0E171E373935	Ramp Type: BlendTrans1	Initial Pass/Fail: Fail	Overall Compliance: No
			Severity Score: 33.75

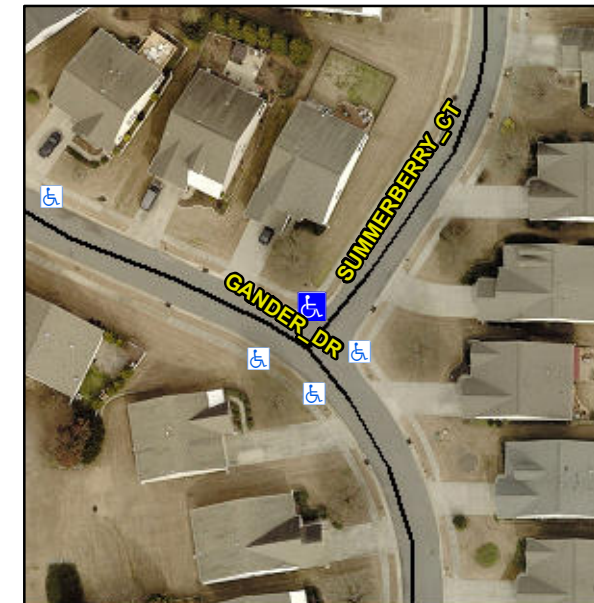
Not Found, R304.5.1, R304.5.3

Compliance	Description	Data	Compliance	Description	Data
N/A	Ramp Length (in)	46.0	Yes	BlendTrans Slope (%)	1.8
No	Ramp Width (in)	46.0	No	BlendTrans XSlope (%)	9.6
N/A	Flare Type LT	N/A	N/A	Flare Type RT	N/A
N/A	Flare Slope LT (%)	N/A	N/A	Flare Slope RT (%)	N/A
N/A	Flare Traversable LT?	N/A	N/A	Flare Traversable RT?	N/A
N/A	Landing Length (in)	N/A	N/A	DWS Provided?	N/A
N/A	Landing Width (in)	N/A	N/A	DWS Contrast?	N/A
N/A	Landing Slope (%)	N/A	N/A	DWS Length (in)	N/A
N/A	Landing X Slope (%)	N/A	N/A	DWS Full Width?	N/A
N/A	Landing Curb? (Y/N)	N/A	N/A	DWS Offset (in)	N/A
N/A	Shared Landing?	N/A			
N/A	Gutter Ponding?	N/A	N/A	Gutter Slope (%)	N/A
N/A	Gutter Lip Ht (in)	N/A	N/A	Gutter X Slope (%)	N/A
N/A	Painted X Walk1?	No	N/A	Painted X Walk2?	No
	X Walk 1 Direction	To SW		X Walk 2 Direction	To SE
	X Walk 1 Width (in)	N/A		X Walk 2 Width (in)	N/A
	X Walk 1 Slope (%)	7.1		X Walk 2 Slope (%)	1.1
	X Walk 1 X Slope (%)	2.9		X Walk 2 X Slope (%)	8.4

N/A	Ramp inside XWalk1?	N/A	N/A	Ramp inside XWalk2?	N/A
	Road Slope (%)	8.3		Clear Space?	N/A
	Road X Slope (%)	4.8	N/A	Clear Space to XWalk (in)	N/A
N/A	Any Obstructions?	N/A	N/A	Storm Grate/Utility Hazard?	N/A
	Obstruction Type			Storm Grate/Utility Type	
		N/A			N/A
			Yes	Surface Condition? (G/P)	Good
			No	Curb Slope (%)	14.4

Remove & Replace Curb Ramp With Two New Directional Ramps or Equivalent.
