# Access Compliance Report

## Public Rights-of-Way

### (Curb Ramps)

| Intersection ID: N/A | Main Street: NOBLES_AV | Cross Street: N/A | Location: SW |

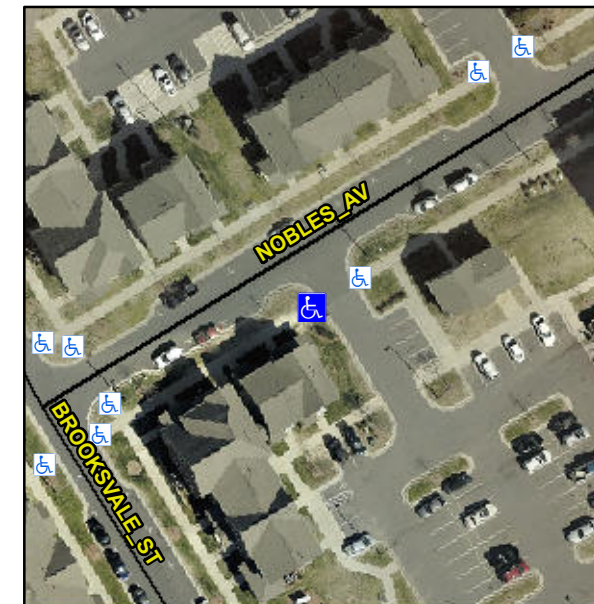
| ADA ID: 0E1ACD8C6A89 | Ramp Type: Perp | Initial Pass/Fail: Fail | Overall Compliance: No |
| Severity Score: 1.25 | | | |

**Not Found, R304.5.3**

| Compliance | Description | Data | Compliance | Description | Data |
|---|---|---|---|---|---|
| N/A | Ramp Length (in) | 72.0 | Yes | Ramp Slope (%) | 7.3 |
| Yes | Ramp Width (in) | 70.0 | No | Ramp XSlope (%) | 2.5 |

**Remove & Replace Entire Ramp.**

Total Cost: \$ 1850.00
