# Access Compliance Report

## Public Rights-of-Way

### (Curb Ramps)

Intersection ID: 17011	Main Street: DELANE_AV	Cross Street: LOMAX_AV	Location: W
ADA ID: 0E200487C9B7	Ramp Type: Para	Initial Pass/Fail: Fail	Overall Compliance: No
Codes/Mitigation Info/Possible Solution		Field Measurements/Component Compliance

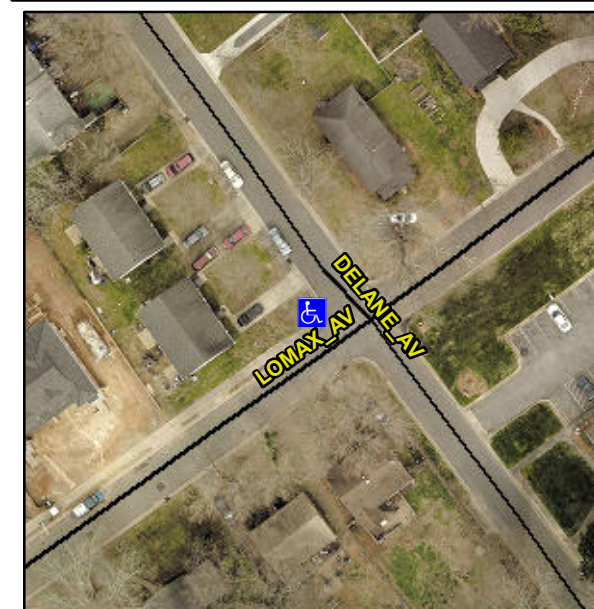
**RT RP < 5%**

**R304.3.2, R304.5.3**

Compliance	Description	Data	Compliance	Description	Data
N/A	Ramp Length LT (in)	34.0	N/A	Ramp Length RT (in)	43.0
Yes	Ramp Width LT (in)	65.0	Yes	Ramp Width RT (in)	59.0
No	Ramp Slope LT (%)	8.9	Yes	Ramp Slope RT (%)	3.9
Yes	Ramp XSlope LT (%)	2.0	No	Ramp XSlope RT (%)	3.1
N/A	Landing Length (in)	N/A	N/A	DWS Provided?	N/A
N/A	Landing Width (in)	N/A	N/A	DWS Contrast?	N/A
N/A	Landing Slope (%)	N/A	N/A	DWS Length (in)	N/A
N/A	Landing X Slope (%)	N/A	N/A	DWS Full Width?	N/A
N/A	Landing Curb? (Y/N)	N/A	N/A	DWS Offset (in)	N/A
N/A	Shared Landing?	N/A			
N/A	Gutter Ponding?	N/A	N/A	Gutter Slope (%)	N/A
N/A	Gutter Lip Ht (in)	N/A	N/A	Gutter X Slope (%)	N/A
N/A	Painted X Walk1?	No	N/A	Painted X Walk2?	N/A
	X Walk 1 Direction	To E		X Walk 2 Direction	N/A
N/A	X Walk 1 Width (in)	N/A	N/A	X Walk 2 Width (in)	N/A
	X Walk 1 Slope (%)	6.4		X Walk 2 Slope (%)	N/A
	X Walk 1 X Slope (%)	2.2		X Walk 2 X Slope (%)	N/A
N/A	Ramp inside XWalk1?	N/A	N/A	Ramp inside XWalk2?	N/A

Road Slope (%)	N/A	N/A	Clear Space?	N/A
	Road X Slope (%)	N/A	N/A	Clear Space to XWalk (in)	N/A
N/A	Any Obstructions?	N/A	N/A	Storm Grate/Utility Hazard?	N/A
	Obstruction Type			Storm Grate/Utility Type	
		N/A			N/A
			Yes	Surface Condition? (G/P)	Good
			N/A	Curb Slope (%)	10.1

**Remove & Replace Entire Ramp.**
